**Re-Evaluation of The Magnitude of Historic Floods
on the Skagit River near Concrete**

**K.M. Leytham
Northwest Hydraulic Consultants**

Skagit County Public works

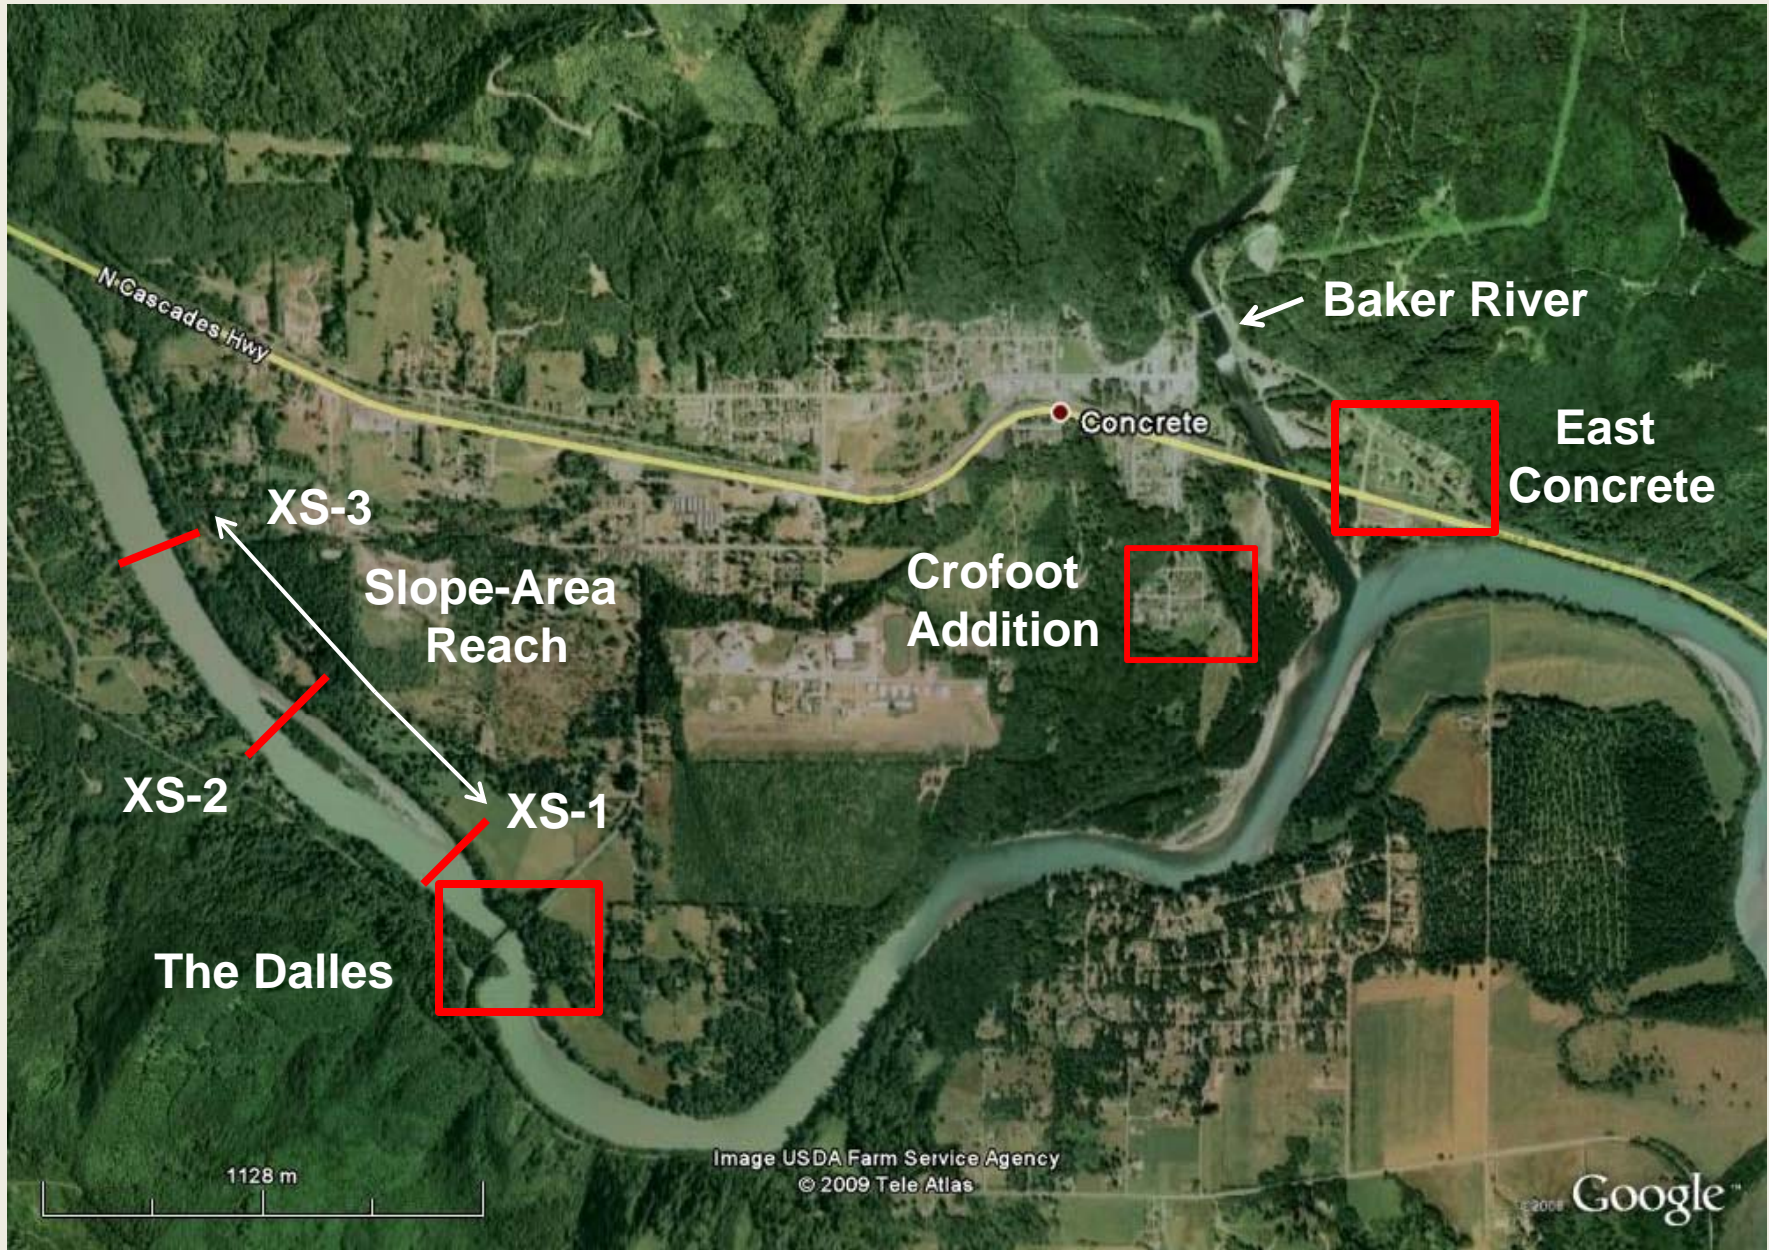
XS-3

Slope-Area
Reach

XS-2

XS-1

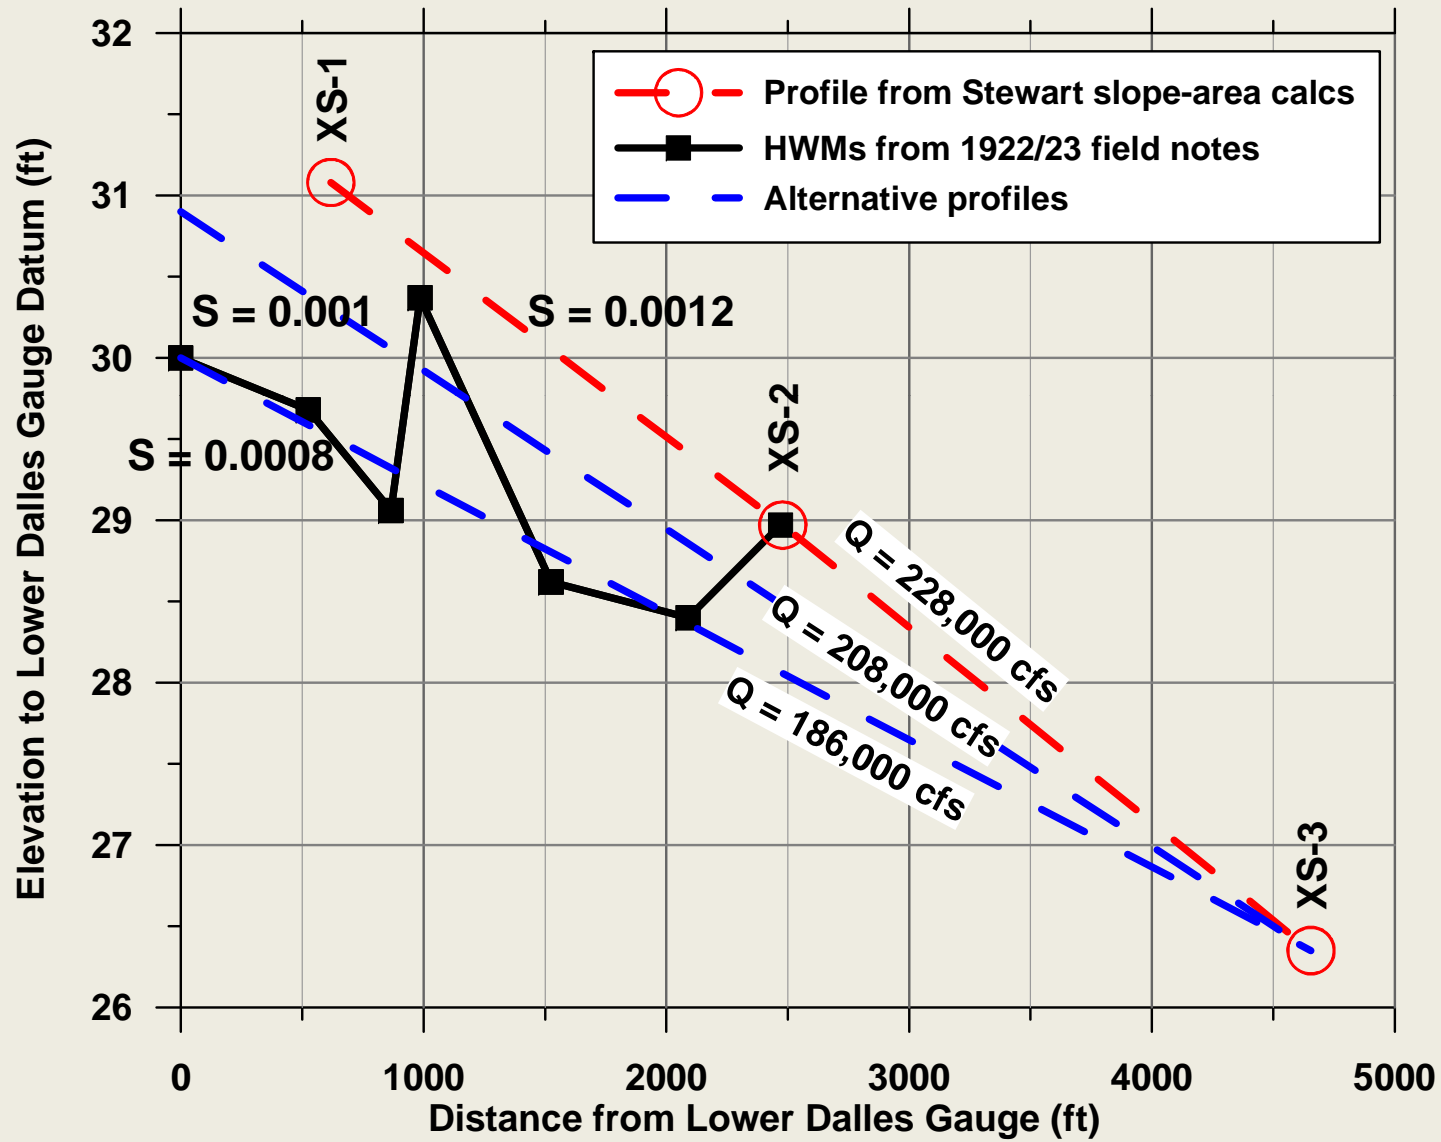
HWMs and Water Surface Profile 1921 Flood

- HWMs in the slope-area reach are based on natural indicators such as sand deposited in moss on trees, moss scoured from trees, mud marks, drift along bank lines.
- HWMs were identified and surveyed more than a year after the event (January and March 1923).
- Unexplained inconsistencies exist between HWM data in field notes and profile used in slope-area calculations.

- Insufficient information to allow us to relate Stewart's assumed water surface profile to available 1921 HWMs (in particular no absolute HWMs have been located between XS-2 and XS-3).
- Scatter in available HWMs is such that accurate determination of 1921 water surface slope is not possible.
- Estimate of peak discharge is sensitive to uncertainty in slope.

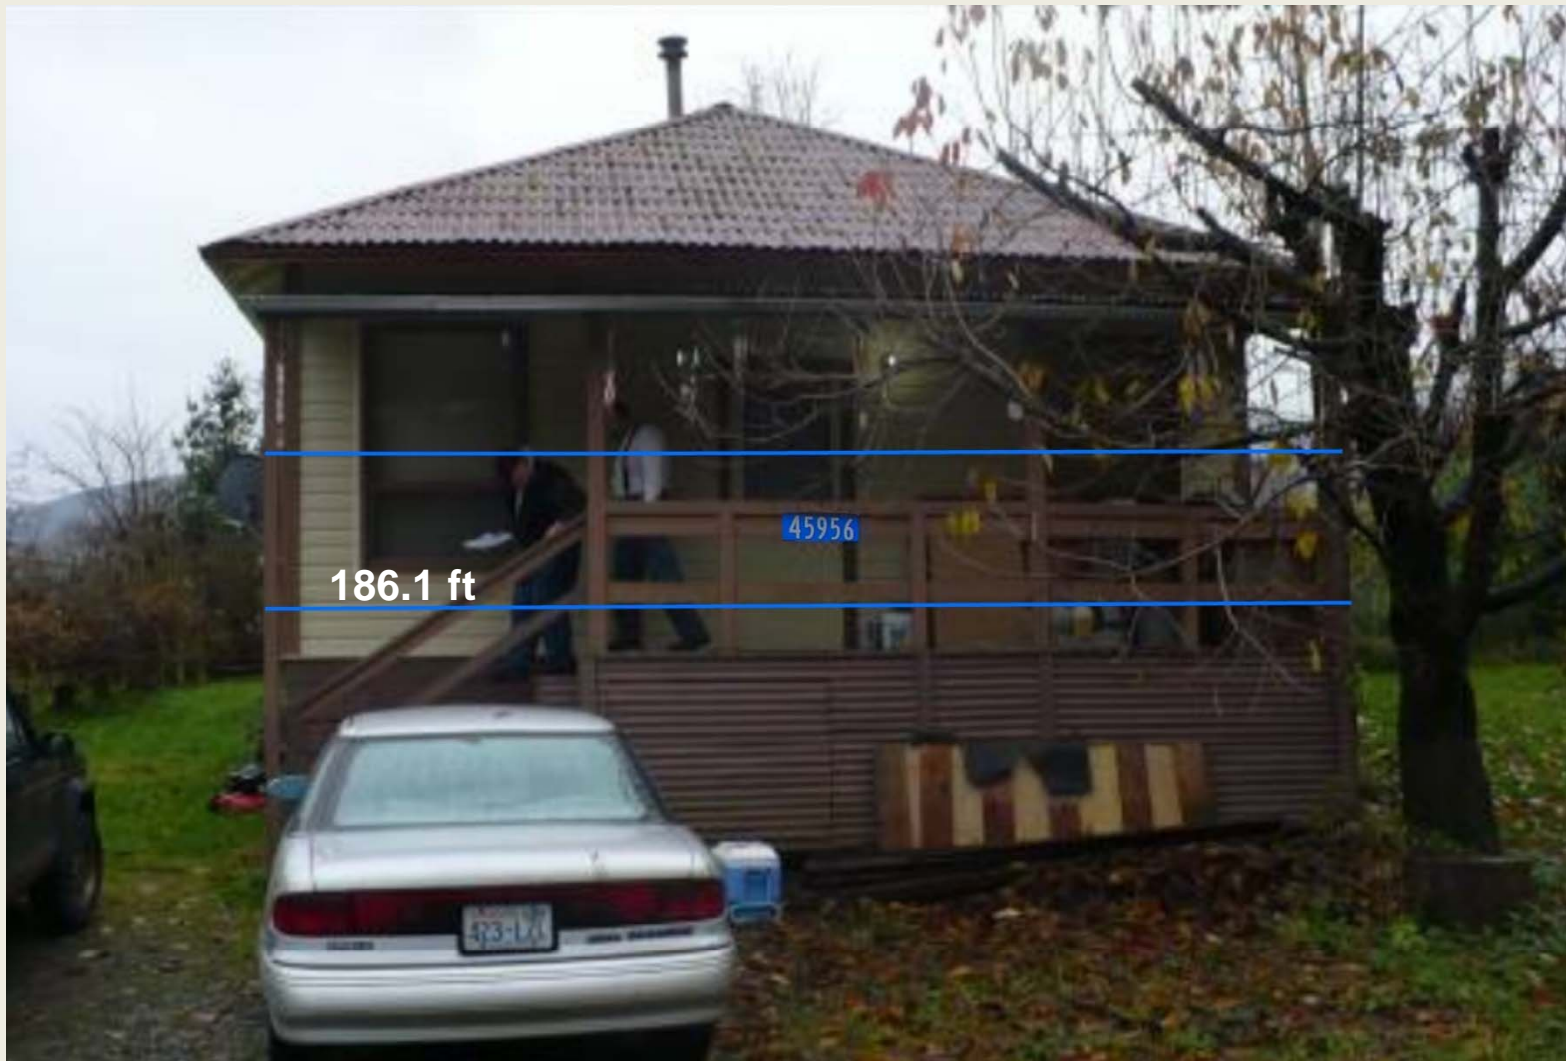
45956 Albert Street, Crofoot Addition showing highest plausible December 1921 water level per Concrete Herald report (186.1 ft)

- Obtain finished floor elevation of lowest remaining residence dating back to 1921 (45956 Albert Street, Concrete).
- Assume 1921 water level was 14 inches above finished floor level. (**Elevation 186.1 ft NGVD 1929**)

This elevation is probably a high-end estimate of water level:

- Results in HWM within 6 inches of floor level for East Concrete residence – inconsistent with statement that *“waters also crept up around some of the dwellings in East Concrete”*.
- Some homes in Crofoot have been raised in elevation or replaced since 1921 – there may have been lower residences than 45956 Albert Street in 1921.

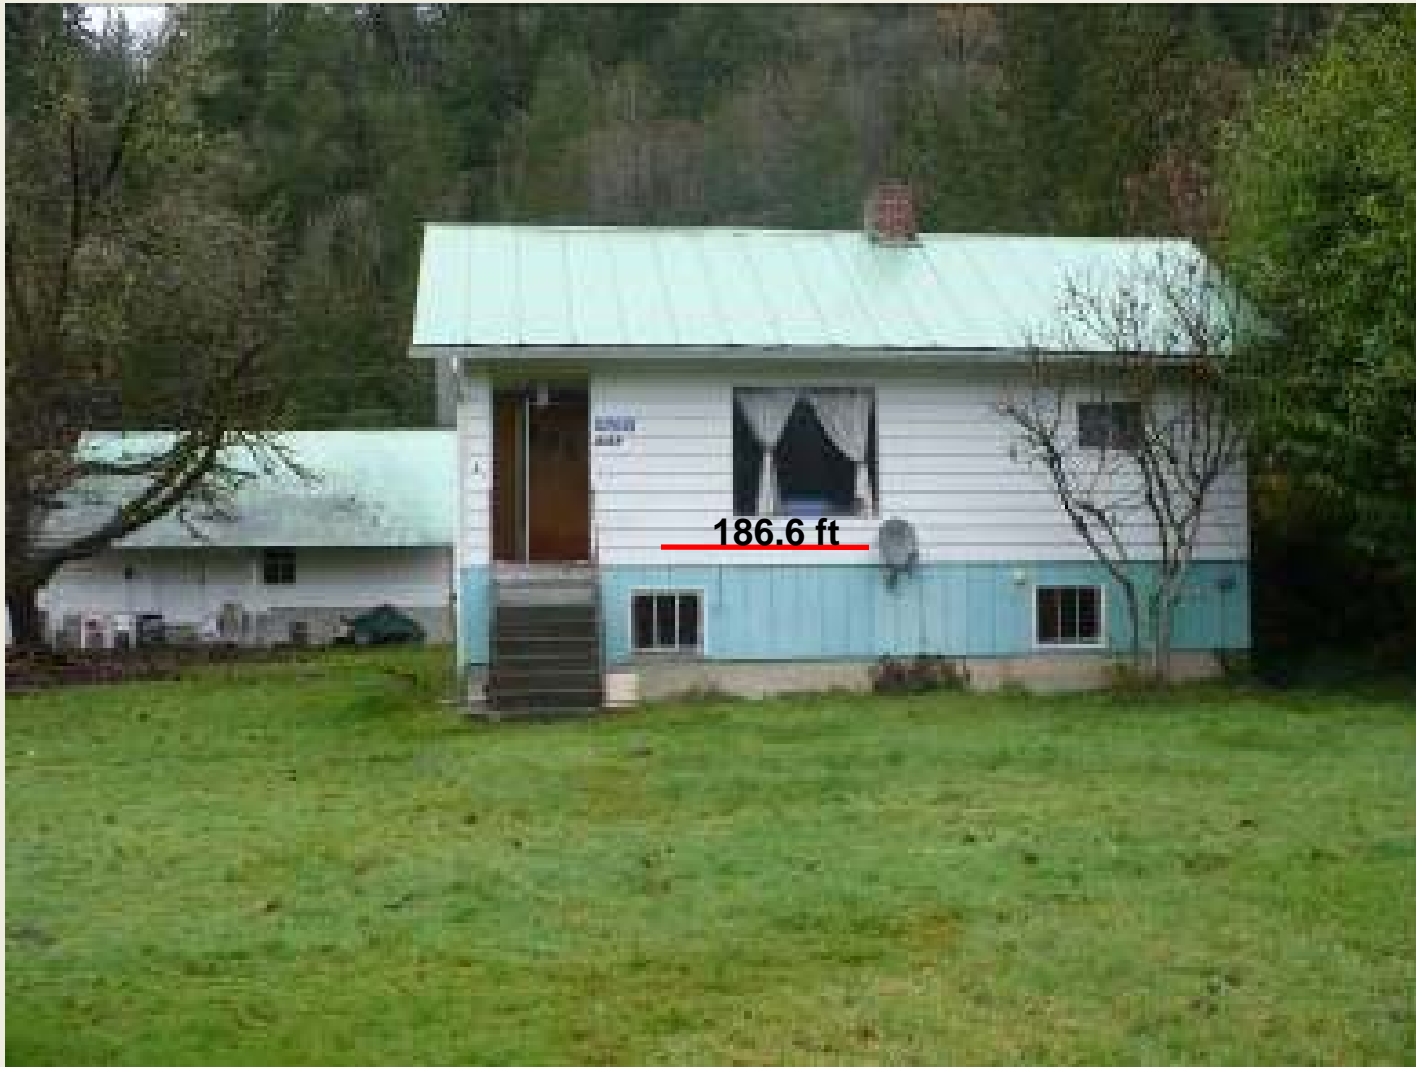
46335 Forest Place, East Concrete showing finished floor level (186.6 ft)

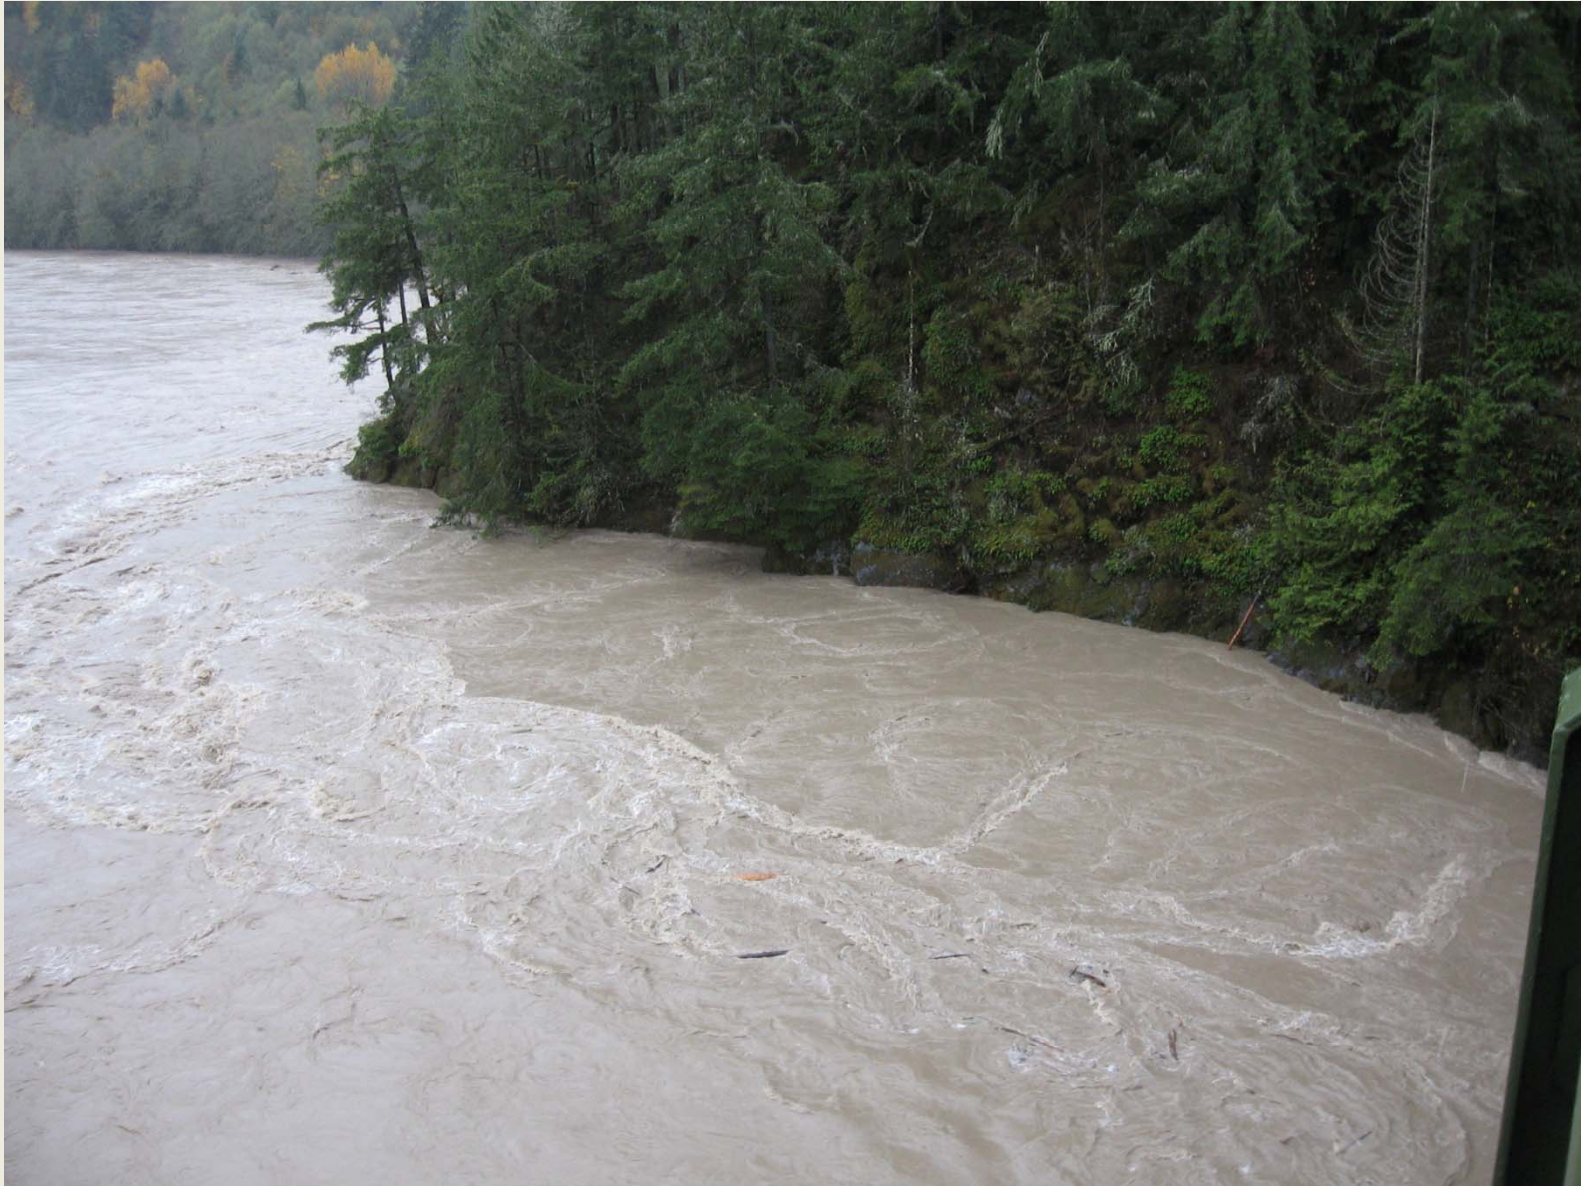
Skagit River at The Dalles, 7 November 2006, $Q = 117,000$ cfs

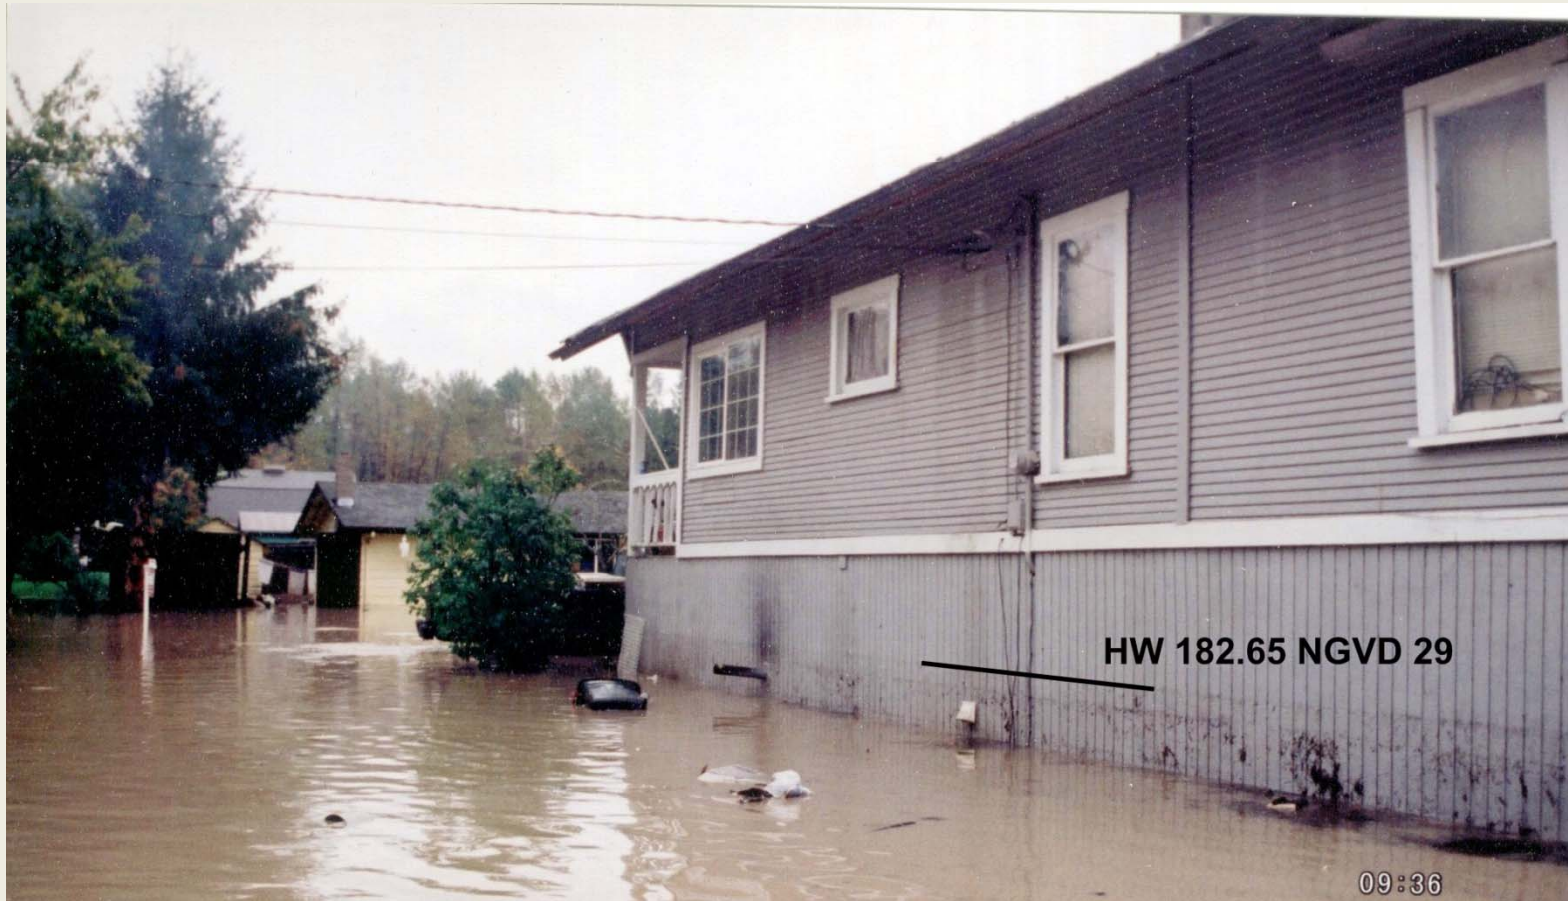
**Jenkins Residence, 7752 South Dillard, Crofoot Addition
21 October 2003**

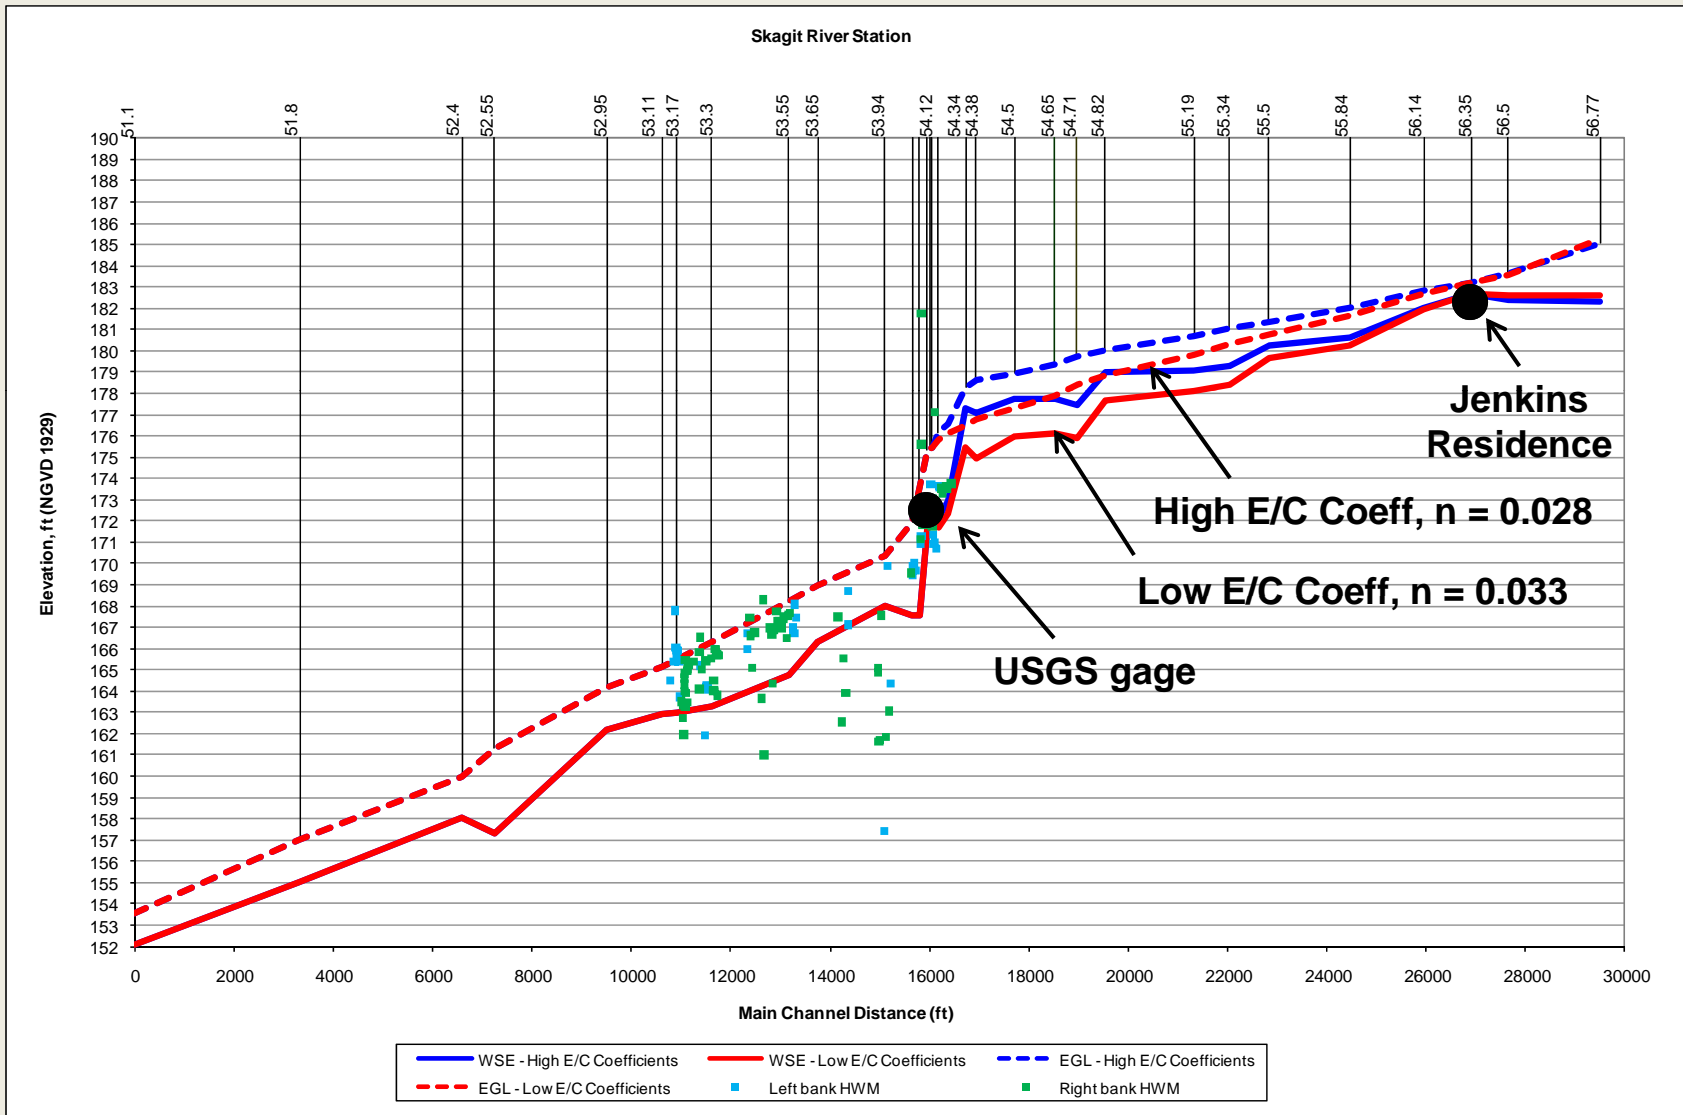
Skagit River HEC-RAS model calibration – October 2003, 166,000 cfs (Priority to match USGS gage rating and Jenkins residence)

Reach	Contraction Coefficient	Expansion Coefficient	In-Channel Roughness
<i>High expansion/contraction coefficient model (High EC)</i>			
RM 51.1 – RM 53.65	0.1	0.3	0.03
RM 53.94 – RM 54.05	0.3	0.5	0.03
RM 54.07 – RM 54.12	0.6	0.9	0.03
RM 54.15 – RM 54.34	0.6	0.9	0.028
RM 54.38	0.3	0.5	0.028
RM 54.50 – RM 56.77	0.1	0.3	0.028
<i>Low expansion/contraction coefficient model (Low EC)</i>			
RM 51.1 – RM 53.65	0.1	0.3	0.03
RM 53.94 – RM 54.05	0.3	0.5	0.03
RM 54.07 – RM 54.12	0.6	0.9	0.03
RM 54.15 – RM 56.77	0.1	0.3	0.033

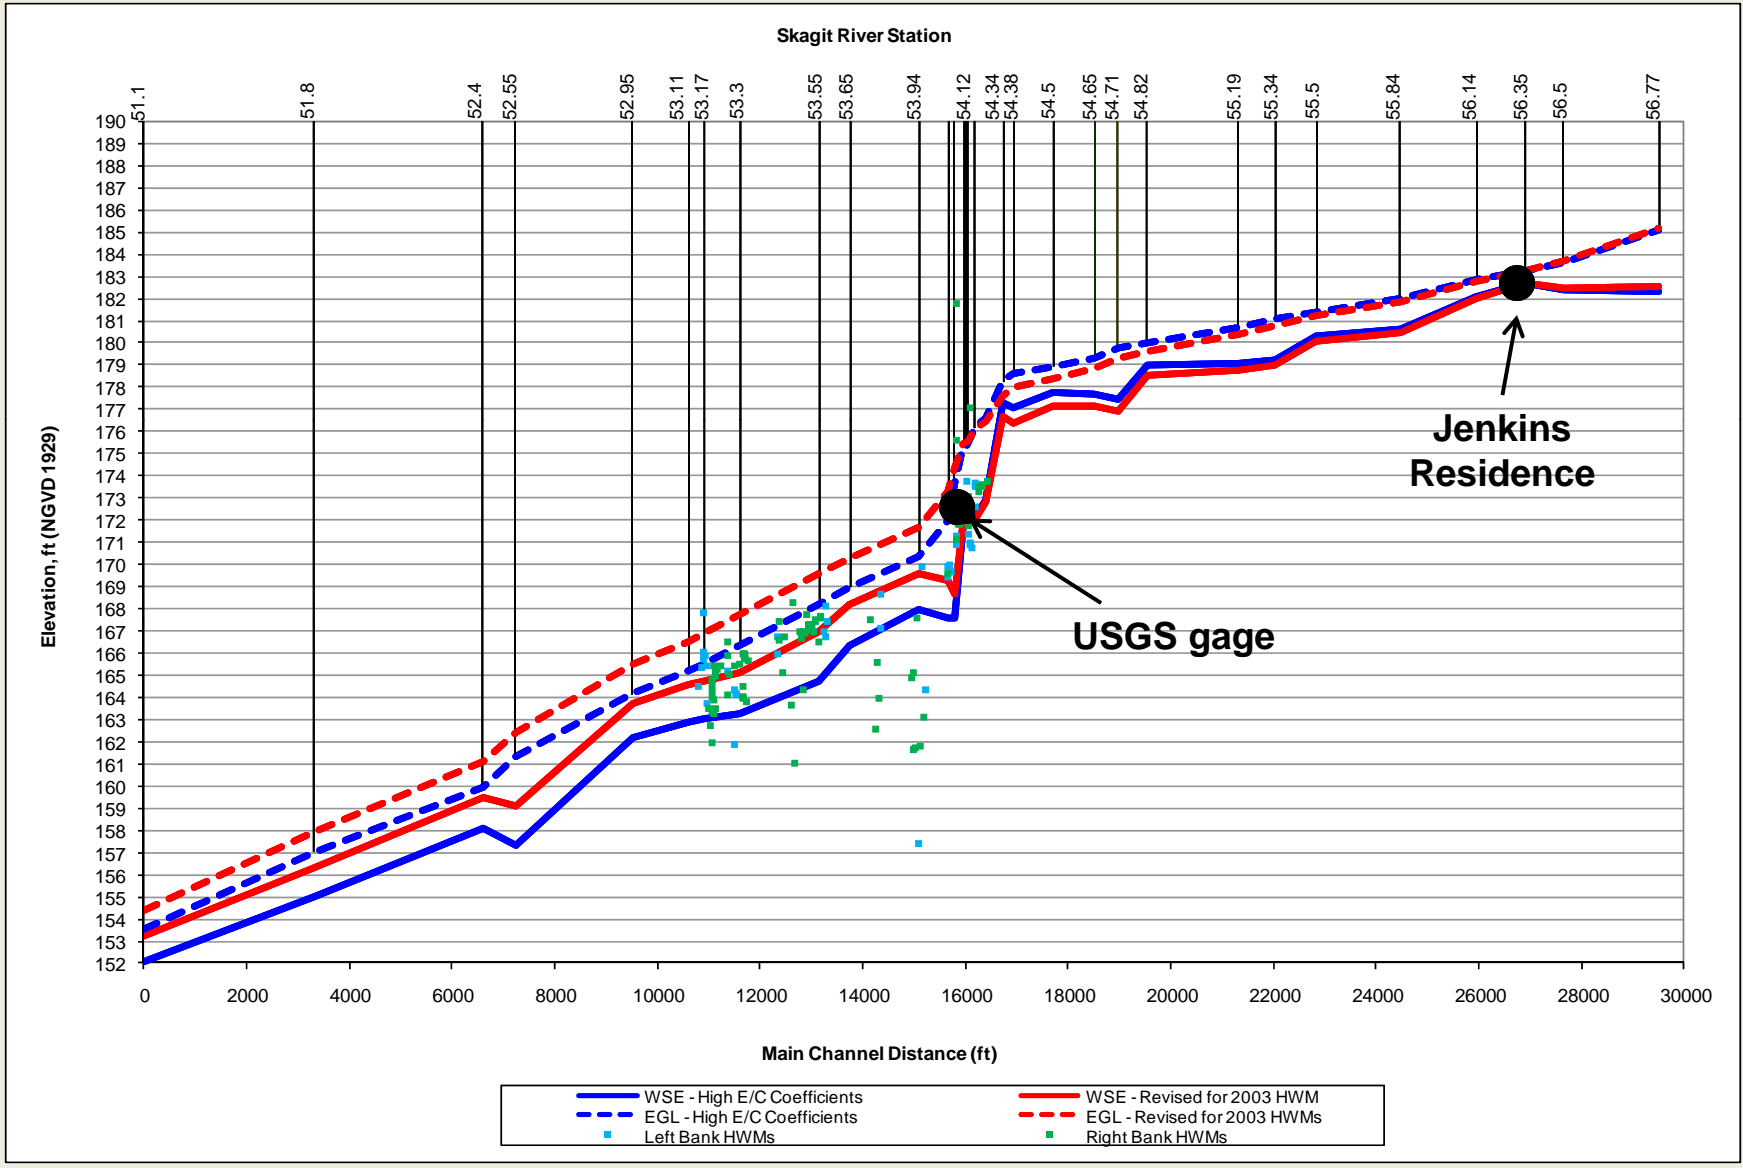
Skagit River HEC-RAS model calibration – October 2003, 166,000 cfs (Match USGS rating, USGS HWMs, Jenkins residence)

Reach	Contraction Coefficient	Expansion Coefficient	In-Channel Roughness
RM 51.1 – RM 53.65	0.1	0.3	0.035
RM 53.94 – RM 54.05	0.3	0.5	0.035
RM 54.07 – RM 54.11	0.4	0.5	0.035
RM 54.12	0.4	0.6	0.035
RM 54.15 – RM 54.34	0.4	0.6	0.03
RM 54.38	0.3	0.5	0.03
RM 54.50 – RM 56.77	0.1	0.3	0.03

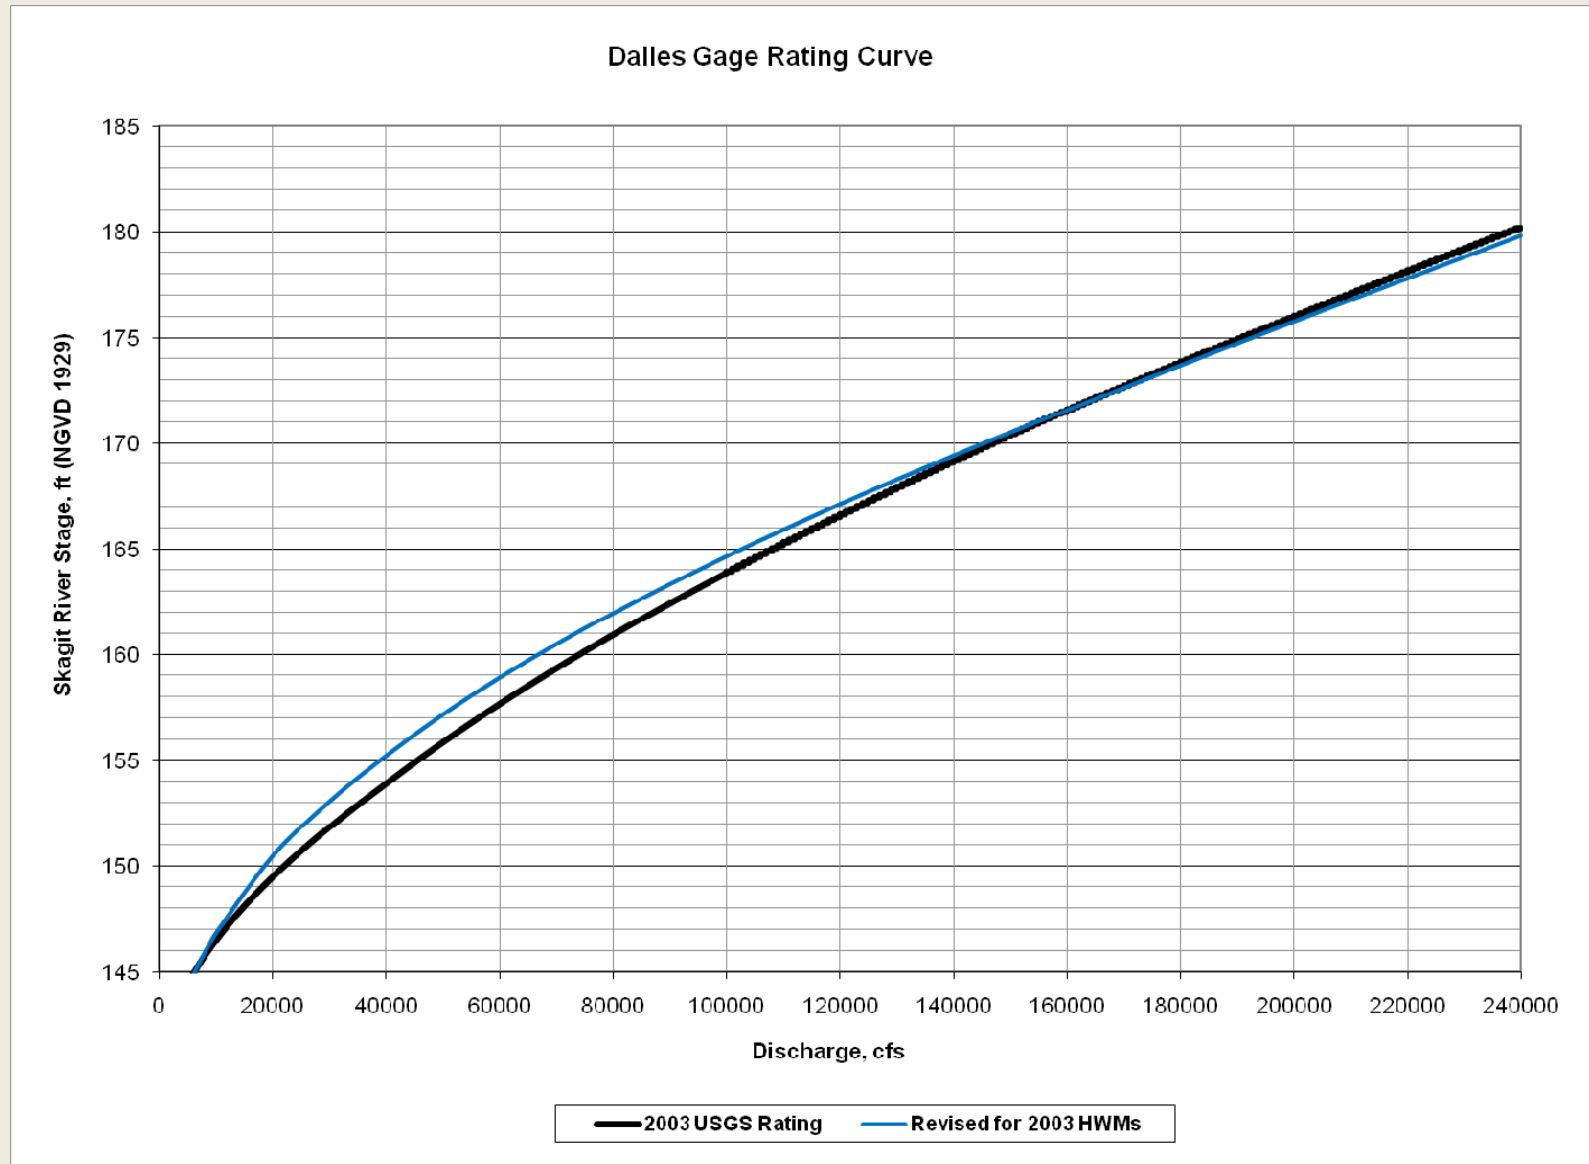
Skagit River HEC-RAS model calibration (Match USGS rating, USGS HWMs, Jenkins residence)

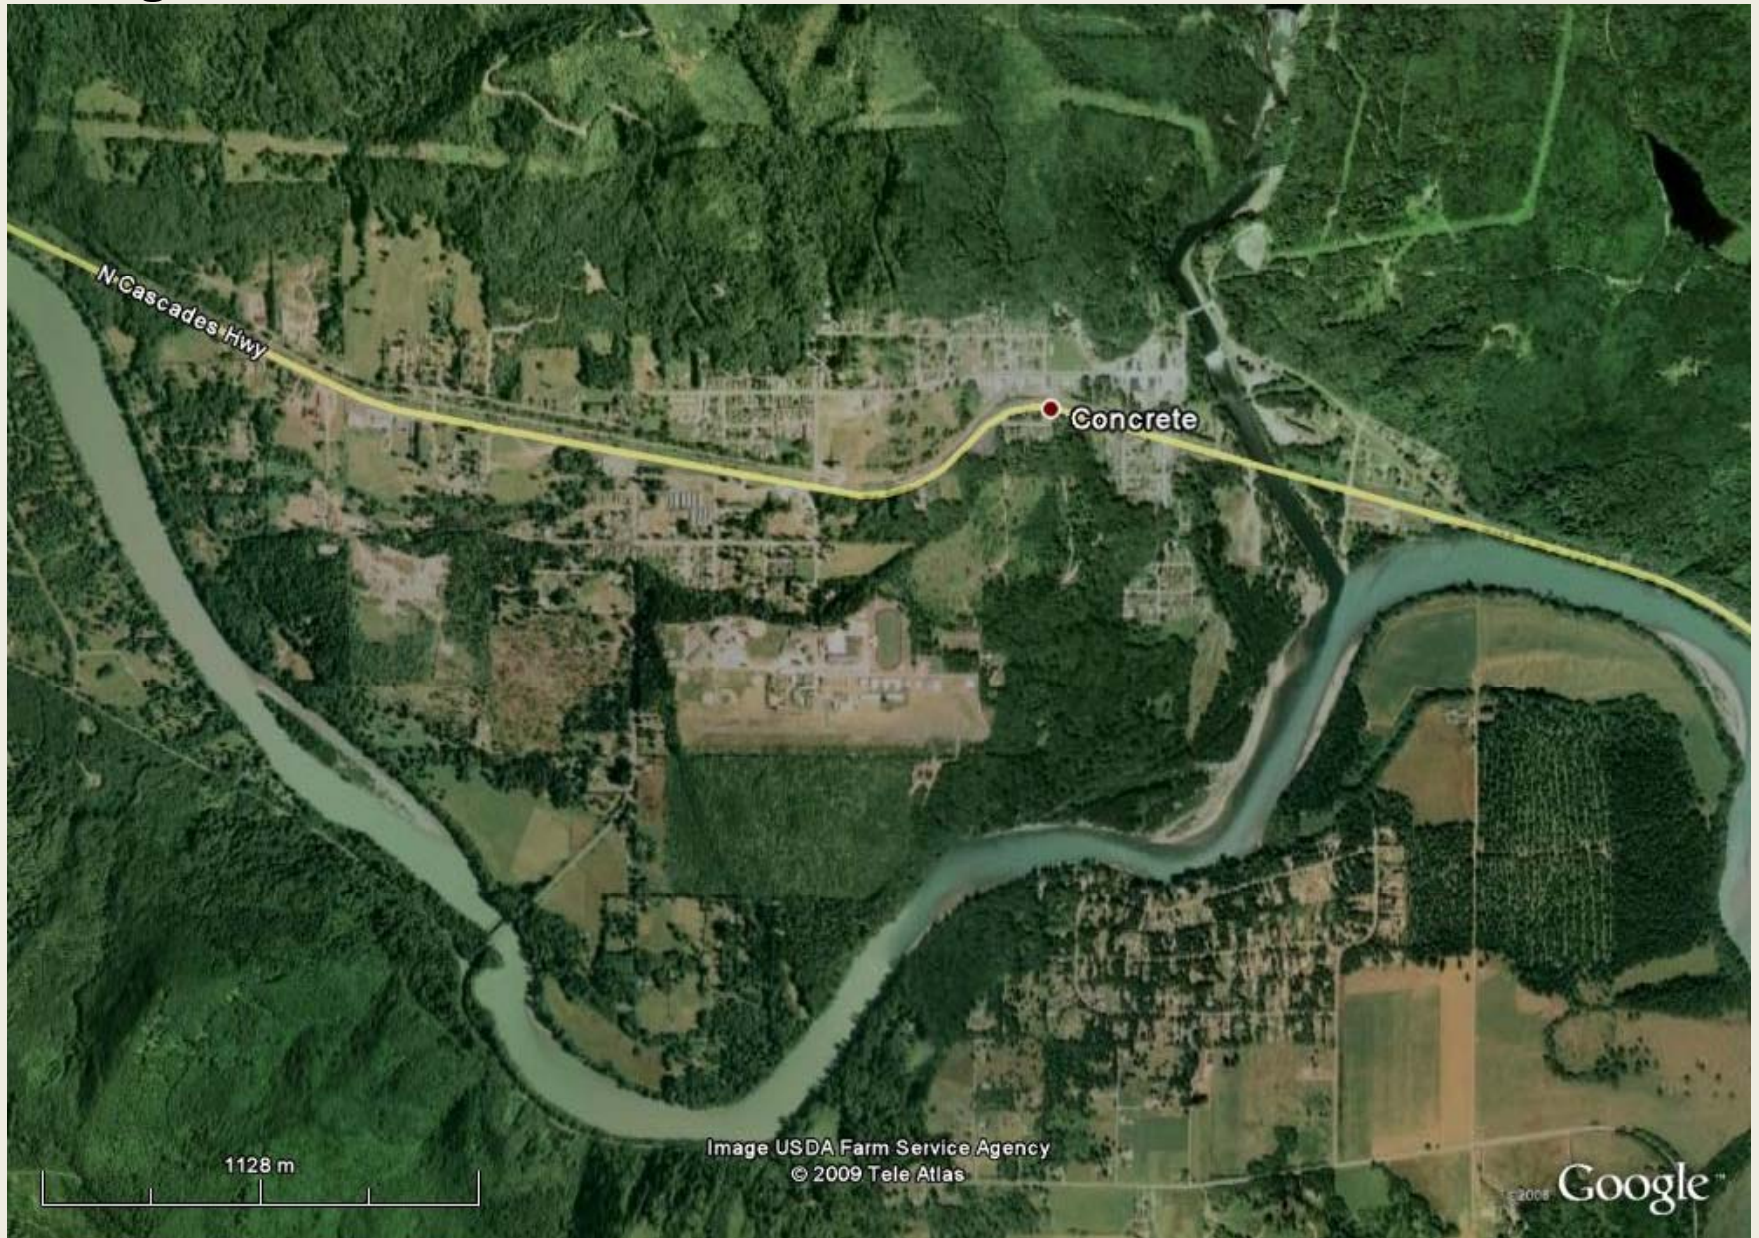
Skagit River, The Dalles to Confluence with Baker River, 2001

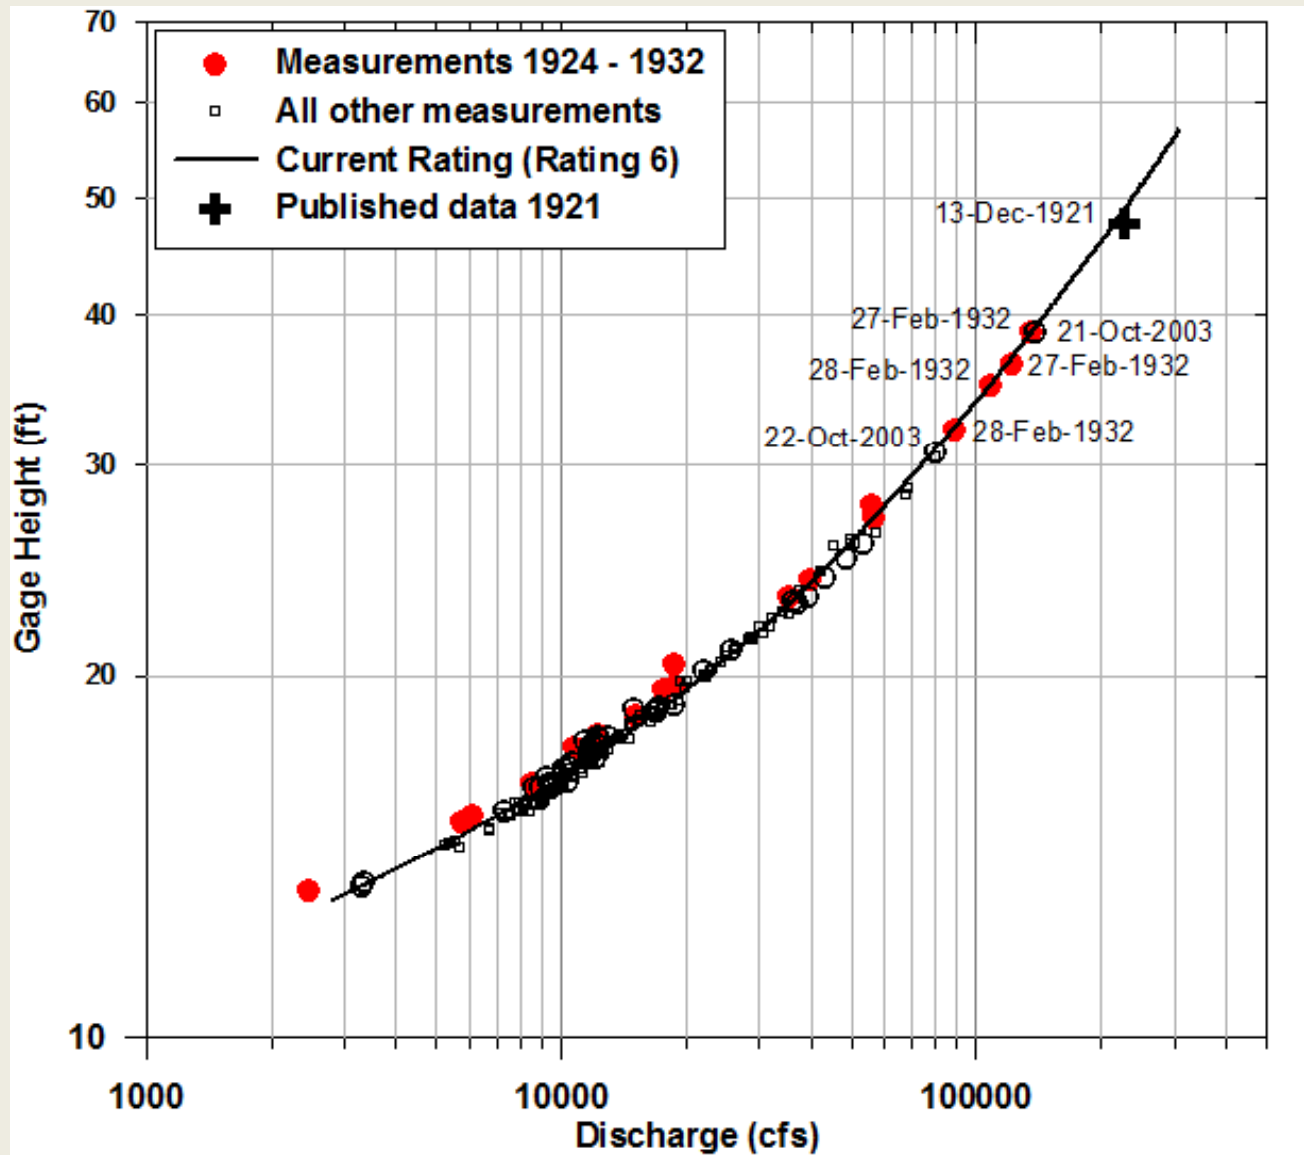
Rating Data, Skagit River near Concrete (The Dalles)

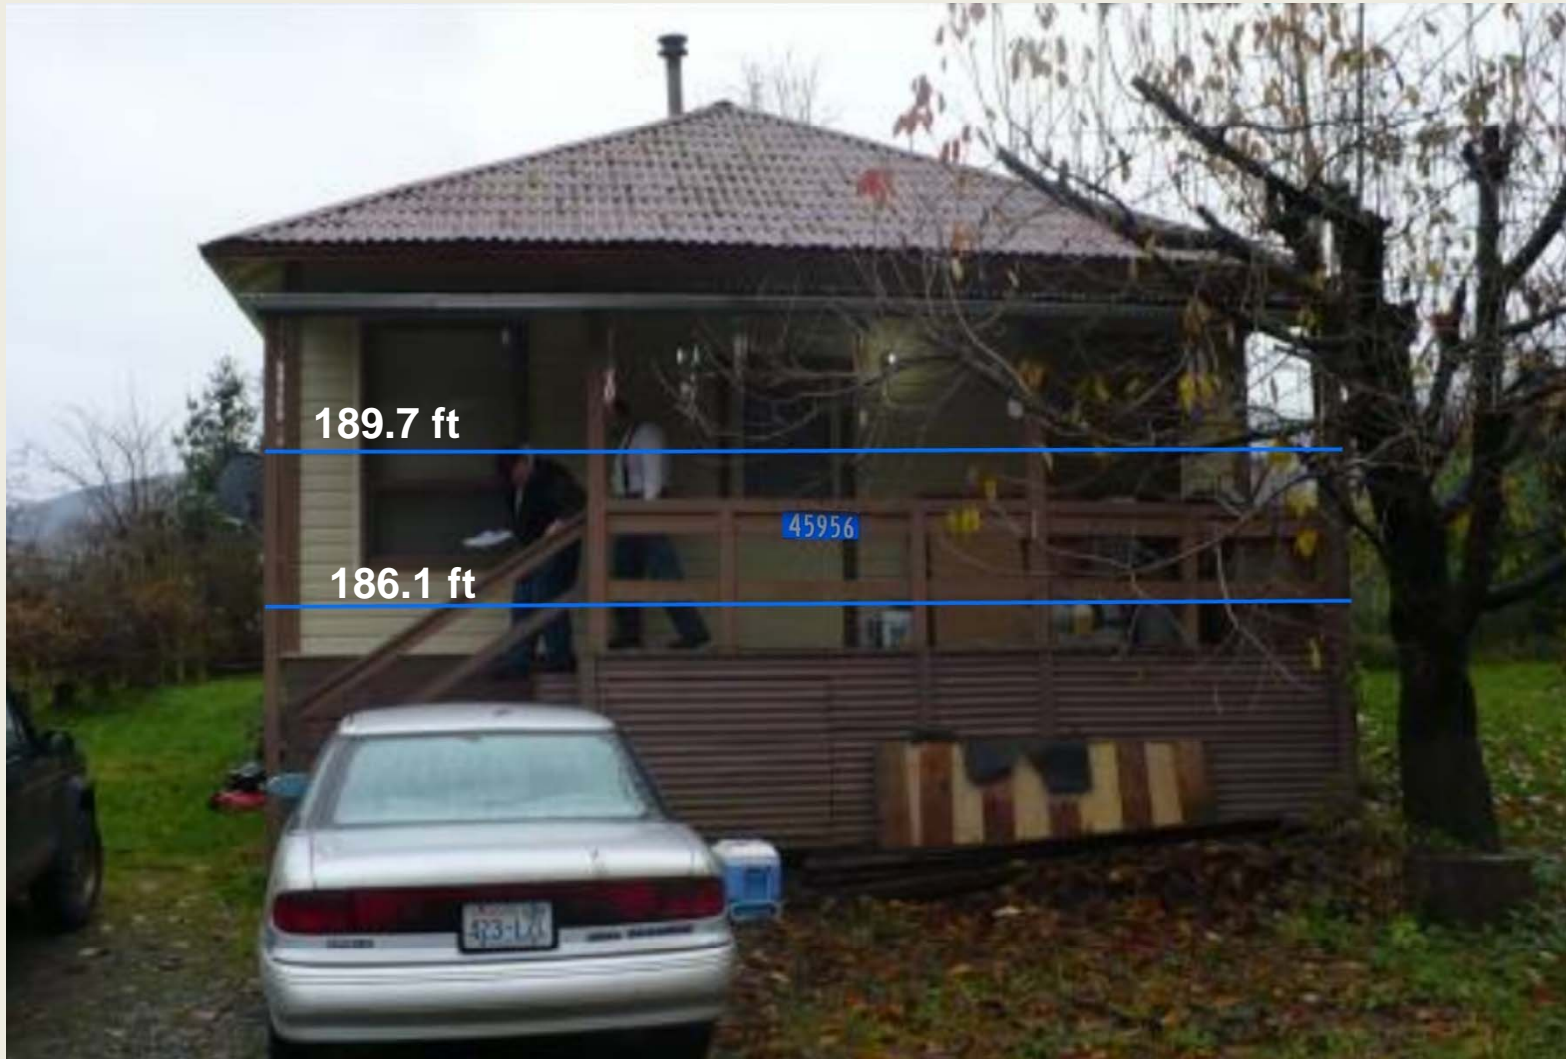
45956 Albert Street, Crofoot Addition showing highest plausible December 1921 water level per Concrete Herald report (186.1 ft) and maximum water level from HEC-RAS model at 228,000 cfs
