## RE-EVALUATION OF THE MAGNITUDE OF HISTORIC FLOODS ON THE SKAGIT RIVER NEAR CONCRETE REVISED FINAL REPORT

**Skagit County Department of Public Works**

**northwest hydraulic consultants**

**Revised 10 March 2010**

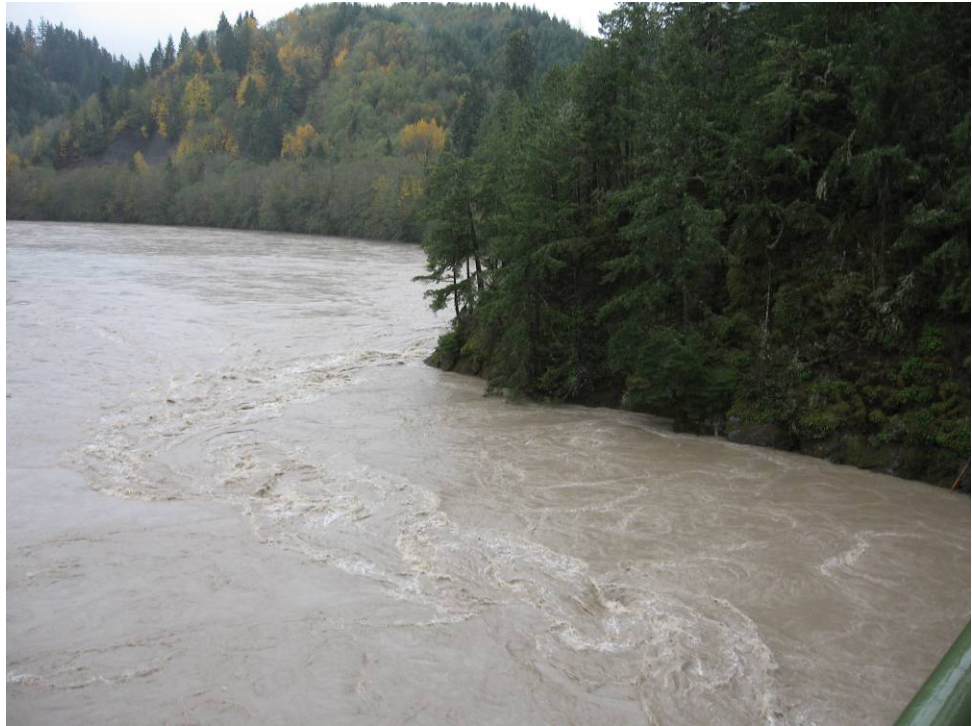
Skagit River at The Dalles looking upstream from The Dalles bridge, 7 November 2006 (120,000 cfs)

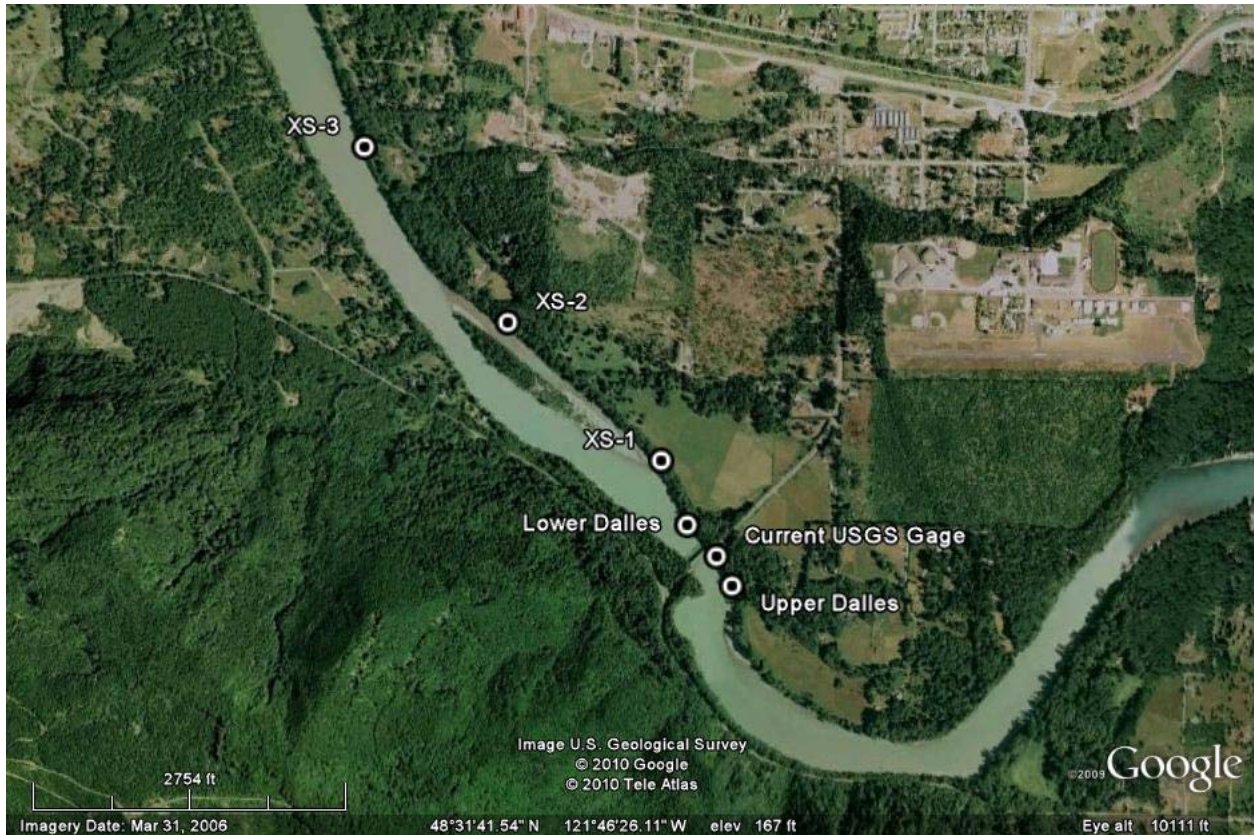
**Figure 2. Location map of slope-area reach**

The slope-area measurements for the 1921 peak discharge are based on high water marks and river cross-section surveys for the reach of the Skagit River below The Dalles shown in Figures 1 and 2. Stewart's slope-area measurements were conducted for reaches XS1-XS2, XS2-XS3 and XS1-XS3, between river miles 53.17 (XS-3) and 53.94 (XS-1), as also shown on Figure 6. Due to adverse hydraulic conditions in reach XS1-XS2, the most recent work by Mastin (2007) relies solely on Stewart's data for the reach XS2-XS3.

The available HWMS are summarized in Table 1 and the HWMs along with the water surface profile assumed by Stewart, as inferred from the 1923 report, are shown in Figure 3. The data are shown relative to the Stewart's Lower Dalles gage (located on Figure 2), as in the original field notes, with HWM elevations also shown to NGVD29<sup>3</sup> assuming a Lower Dalles datum of 142.84m (Stewart [field book page 67] reports a Lower Dalles datum of 141.04 MSL – see discussion of datum discrepancy in Section 3.2). HWM data pertinent to the slope-area reach are only available from 7 locations between the Lower Dalles gage and XS-2. No data are available to provide absolute HWM elevations between XS-2 and XS-3 (Stewart's field book [page 79] includes a high water mark at the lower end of his slope-area reach, but only provides an elevation to an arbitrary datum).

The November 2006 profile shows a break in slope at about station 31+00 (point 162), with a slope of about 0.0016 upstream from that point, and 0.00076 downstream. The break in slope coincides with the downstream end of the large right-bank gravel bar/island (see Figures 1 and 2) which is now forested but which, based on a 1937 aerial photograph (see Figure 11), is assumed to have been bare in 1921. Under current conditions, the bar is believed to be inundated at a flow of about 80,000 cfs.

We surmise that Stewart installed two staff gages at The Dalles in December 1922 – referred to in Stewart's field book as the Upper Dalles Gage and the Lower Dalles Gage. The gage locations, as inferred from Stewart's notes, are shown on Figure 2. The Upper Dalles gage consisted of a vertical upper section and a lower elevation inclined gage. Stewart's notes (page 34/35) for 23 December 1922 refer to "*placing foot graduation marks on inclined gage*".

As noted by others, hydraulic conditions through The Dalles are complex. The river takes two abrupt 90 degree turns immediately upstream from The Dalles gorge which results in flow reversal along the left bank just below the entrance to the gorge and considerable turbulence (see Figure 2 and the cover photo taken during field investigations on 7 November 2006 at a discharge of 120,000 cfs). The hydraulic conditions through the gorge are not well suited to hydraulic modeling and actual field conditions deviate considerably from the one-dimensional flow assumptions of the HEC-RAS model.

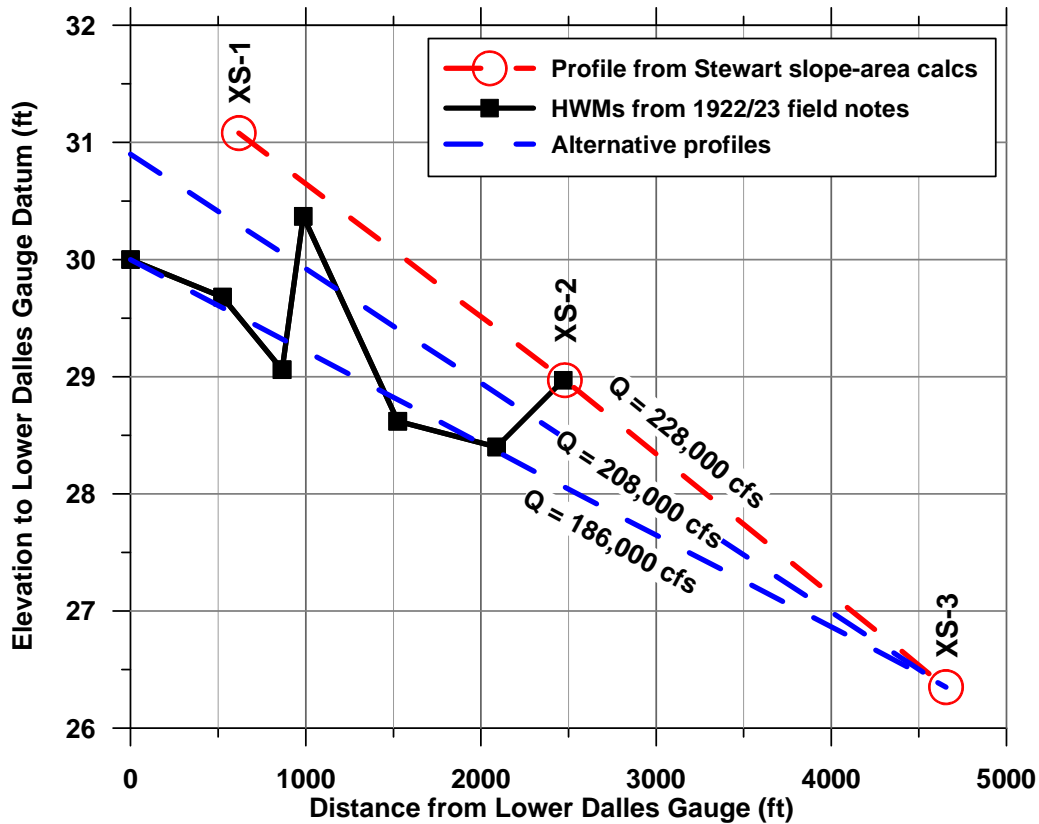
**Figure 3. Stewart’s 1921 HWMs and water surface profile used in slope area calculations**

The profile in Figure 3 for Stewart’s slope-area calculations (showing the current peak discharge estimate of 228,000 cfs) is assumed for the purposes of presentation to pass through the HWM at XS-2. The slope of the profile is based on the fall between XS1 – XS2 (2.11 ft) and between XS2 – XS3 (2.62 ft) as used in both the 1923 calculations and in the recent reevaluation by Mastin (2007) for an average slope of 0.0012. Also shown on Figure 3 are two alternative interpretations of water surface profiles (slopes of about 0.001 and 0.0008) and corresponding approximate discharges (208,000 cfs and 186,000 cfs).

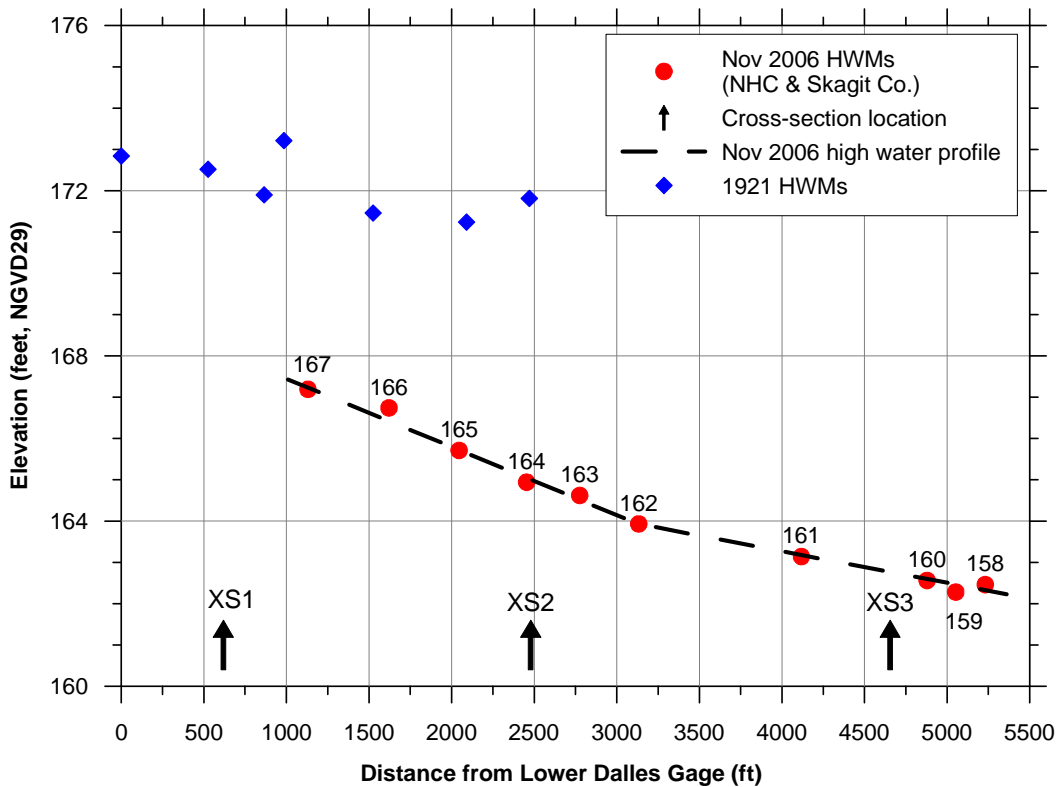
**Figure 4. November 2006 and December 1921 HWMs**

While the water surface profile for the November 2006 flood is well defined, it provides little guidance for interpretation of the 1921 HWMs. Stewart's slope-area calculations for reach XS2-XS3 assume a water surface slope of 0.0012 compared with a slope of 0.00076 from the November 2006 data downstream from the gravel bar. USGS interpretation of its 2006 data (relying only on HWMs between XS2 and XS3) shows a slope of 0.00114. There is clearly considerable scope for uncertainty in the slope area measurements which strongly suggest that alternative approaches to estimation of the peak should be considered.

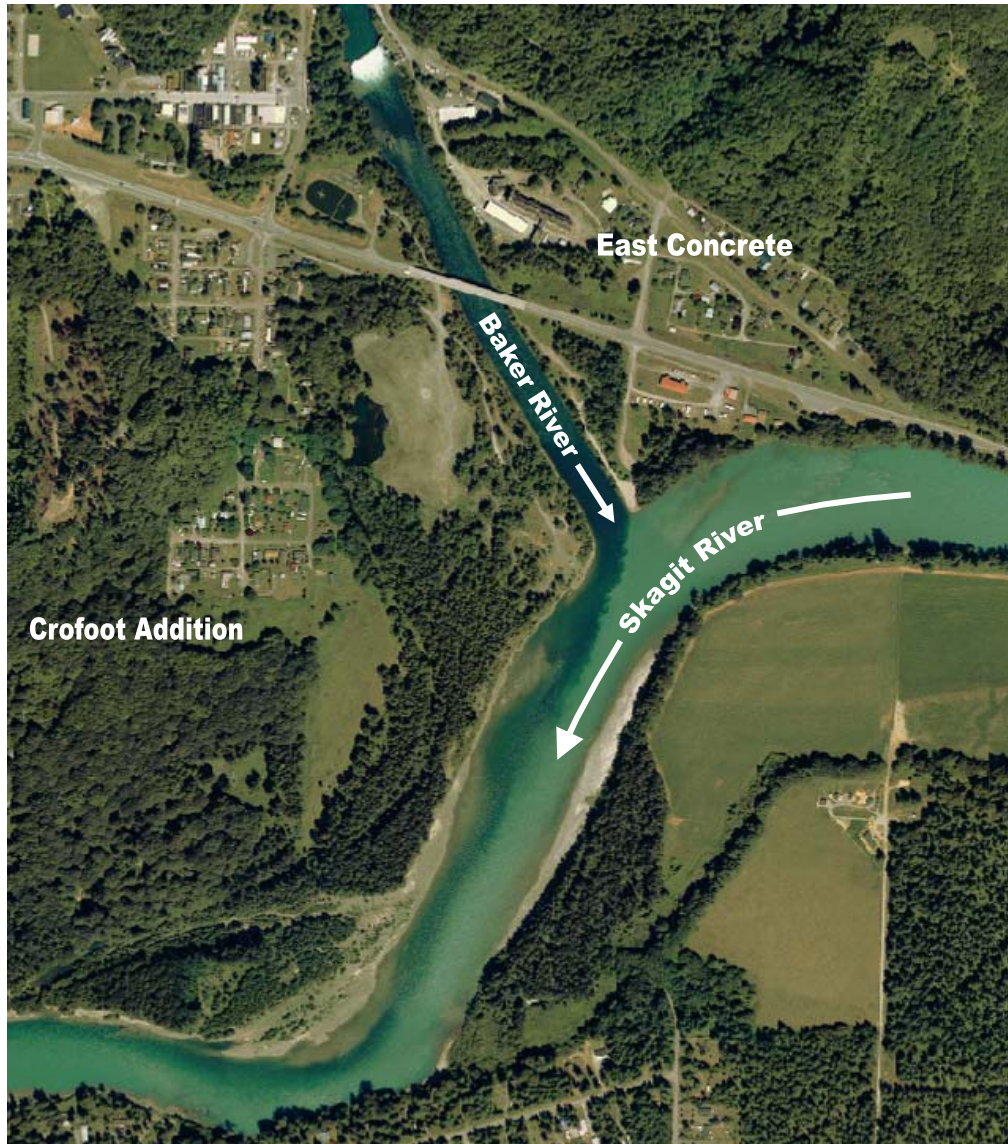
**Figure 5. Crofoot Addition of Concrete and East Concrete, WA (2001).**

The Crofoot Addition is that area of Concrete in the Skagit and Baker River floodplains south of the present alignment of SR-20 and immediately west of the confluence of the Baker and Skagit (see Figure 5). East Concrete is in the floodplain immediately east of the Baker River.

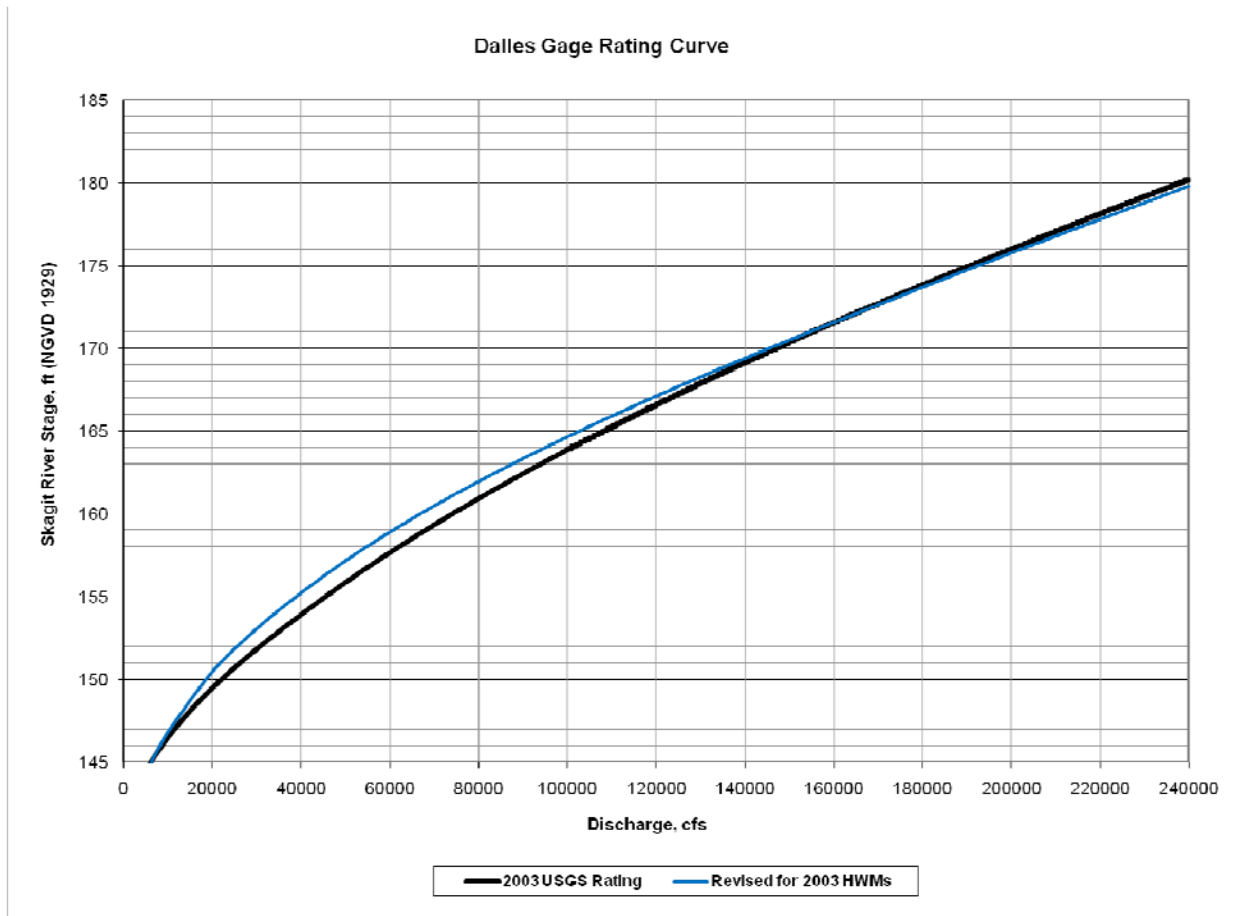
**Figure 16. Comparison of Stage-Discharge Rating at RM 54.12 from Modified Current Condition Model against USGS Rating 6**

Figure 15 shows water surface and energy grade profiles for the current condition high expansion/contraction coefficient model (blue line) from Figure 7 and for the current condition model as modified to better reproduce USGS HWMs for the October 2003 flood (red line). The model reproduction of the October HWMs below The Dalles is significantly improved. However this improvement is at the expense of the match of model results to the gage rating (compare Figures 8 and 16). Nevertheless, the model still provides a good match to the rating in the flow range of greatest interest – above about 140,000 cfs.

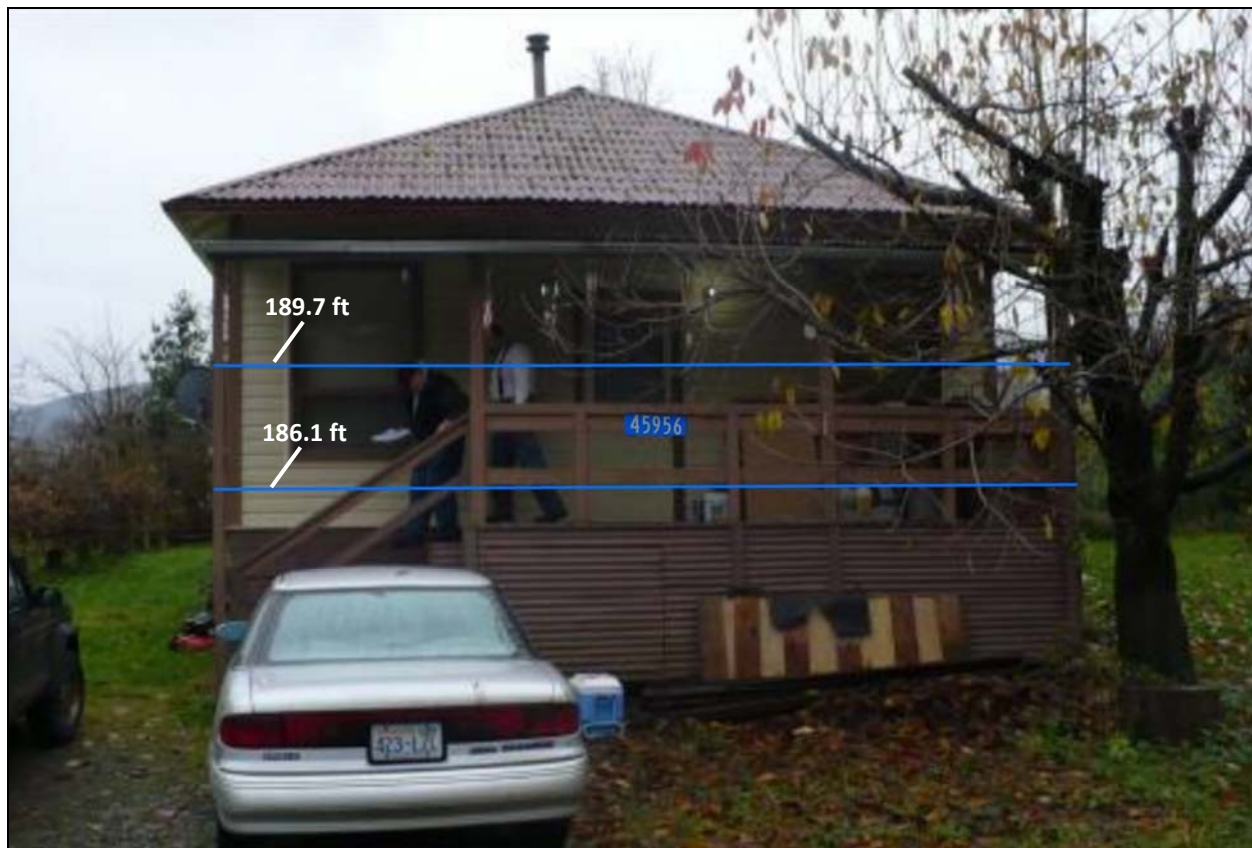
**Figure 17. 45956 Albert Street, showing December 1921 water level as inferred from Concrete Herald report (186.1 ft), and estimated water level corresponding to a discharge of 228,000 cfs (189.7 ft)**

Estimates of the peak discharge from 1921 range from about 187,000 cfs using the HEC-RAS model described above with 1921 channel geometry and overbank conditions (see Table 5), to the currently published value of 228,000 cfs. A somewhat conservative<sup>13</sup> HEC-RAS model relying on current channel geometry produces simulated water surface elevations in the Crofoot Addition ranging from 189.7 to 190.8 ft at a discharge of 228,000 cfs for the combinations of model parameters bracketing their probable actual values (see Table 4). Based on first-hand observations reported in the Concrete Herald, the maximum water level in the Crofoot Addition during the 1921 flood was at most 186.1 ft. These water levels are shown in Figure 17 superimposed on a photograph of the lowest existing house in the Crofoot Addition dating from 1921 (45956 Albert Street).

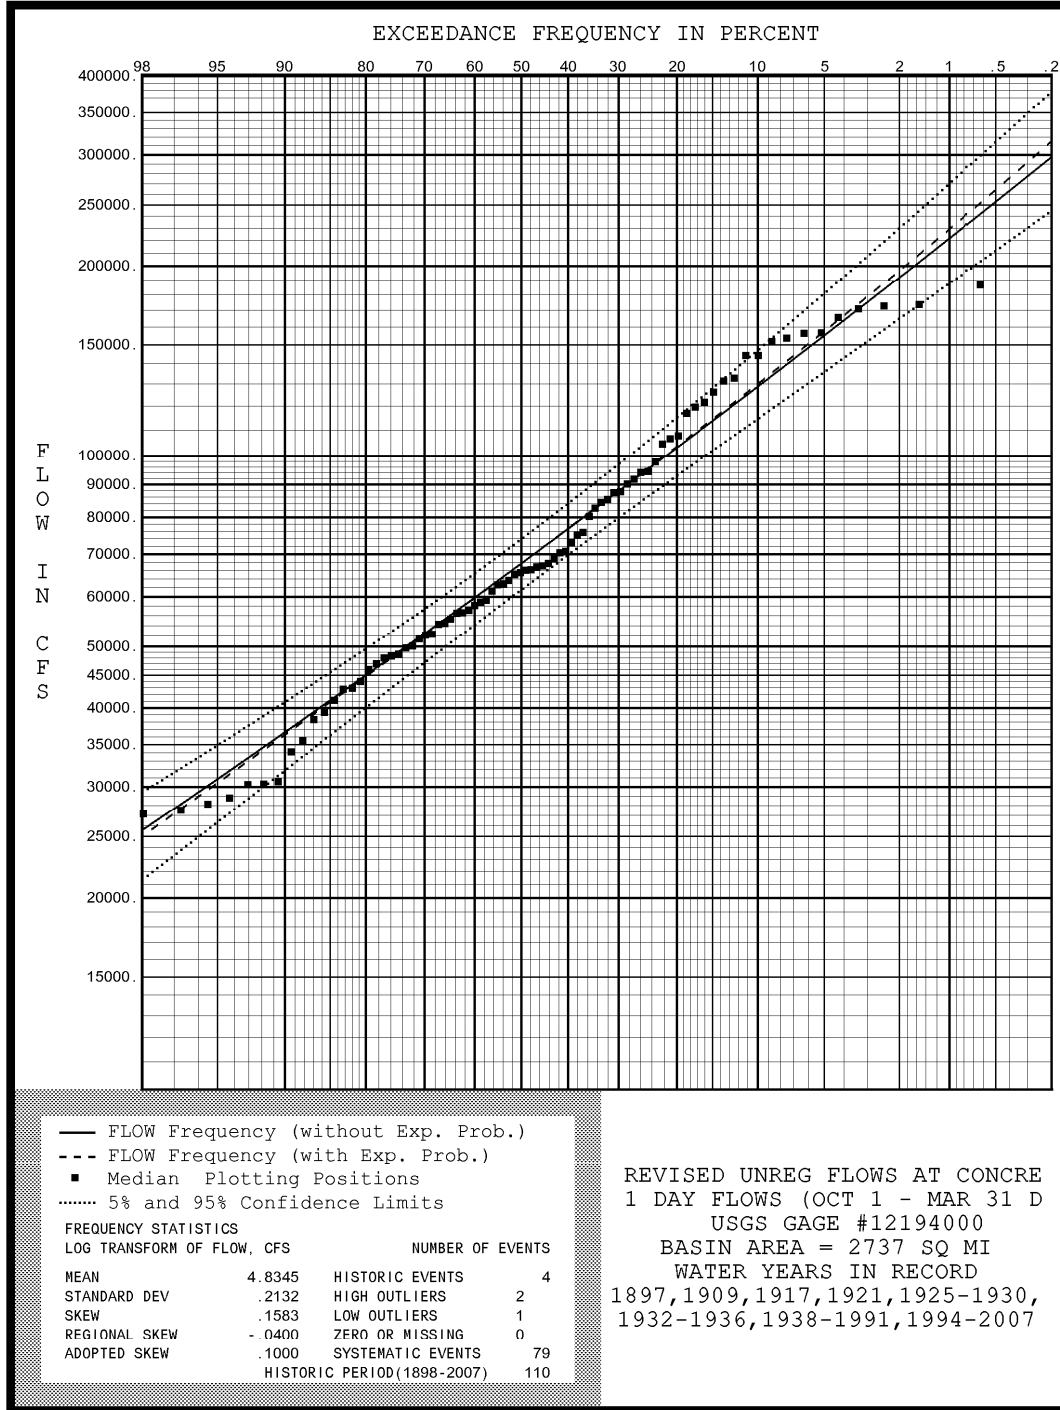
Figure 21. Frequency Analysis, Revised Unregulated 1-Day Discharge, Skagit River near Concrete.
