**NOTICE OF PREPARATION/CLEAN WATER ACT PUBLIC
NOTICE**

Public Notice Date: April 1, 2021
Expiration Date: May 3, 2021
Reference: PMP-21-01
Name: Skagit River Diking Districts 3 and 12
Levee Rehabilitation

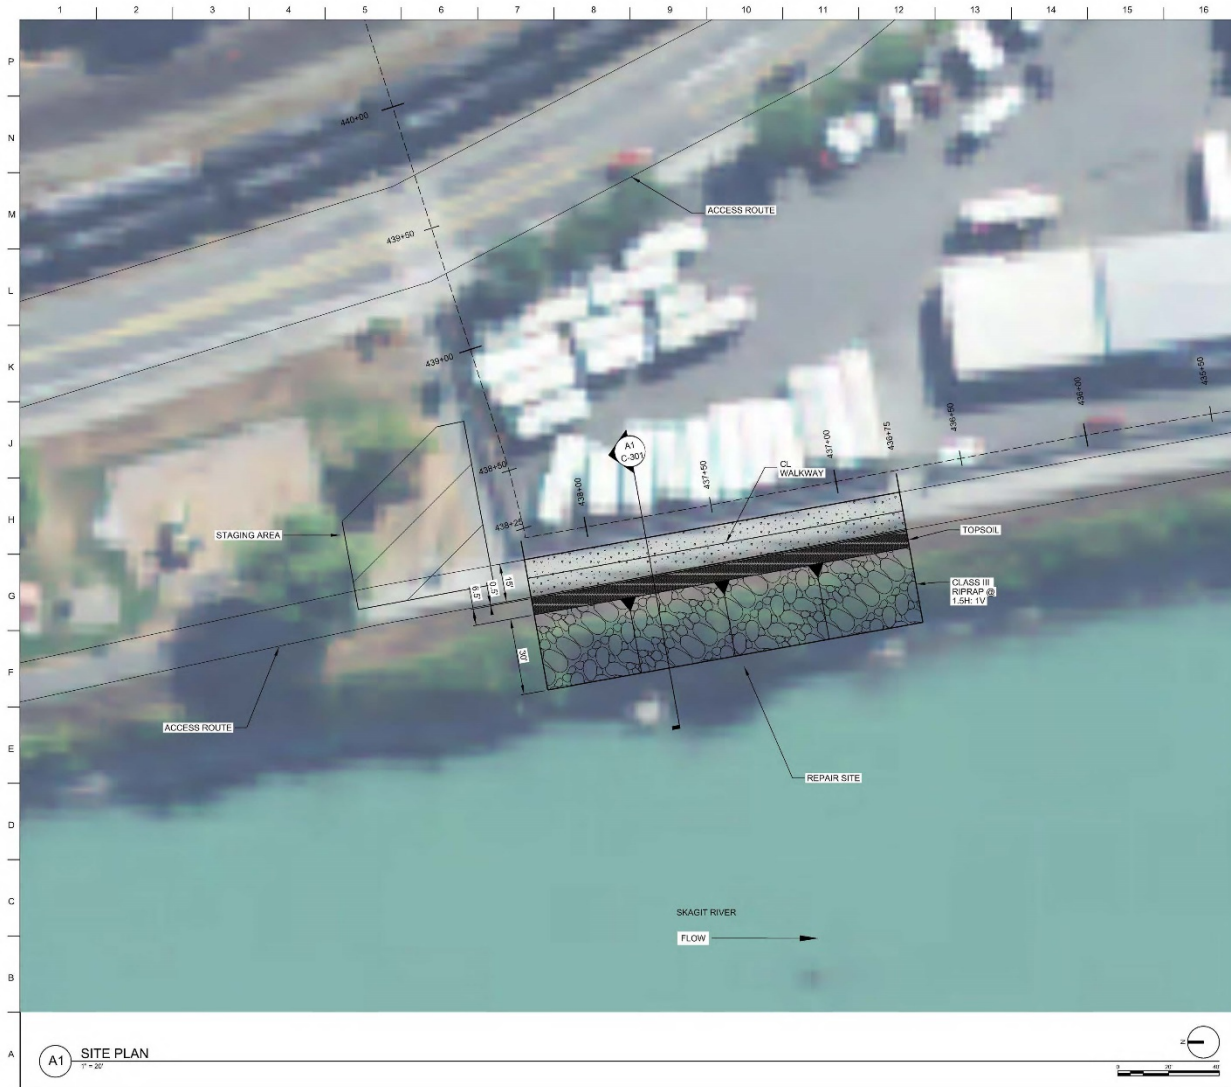
- GENERAL NOTES:**
1. STATIONING DERIVED FROM THE NATIONAL LEVEE DATABASE (NLD). LEVEE REPAIR FROM ST. 430+15 TO 430+25.
 2. EDGES OF NEW LEVEE MUST TRANSITION SMOOTHLY TO EXISTING SURROUNDINGS.
 3. ALL IN-WATER WORK SHALL OCCUR BETWEEN JUNE 15 - AUGUST 31 TO MINIMIZE ECOLOGICAL IMPACT TO WILDLIFE HABITAT.
 4. ASSOCIATED ENVIRONMENTAL MITIGATION SHALL OCCUR AT APPROXIMATELY ST. 330+00. SEE SHEETS L-100 AND L-101.

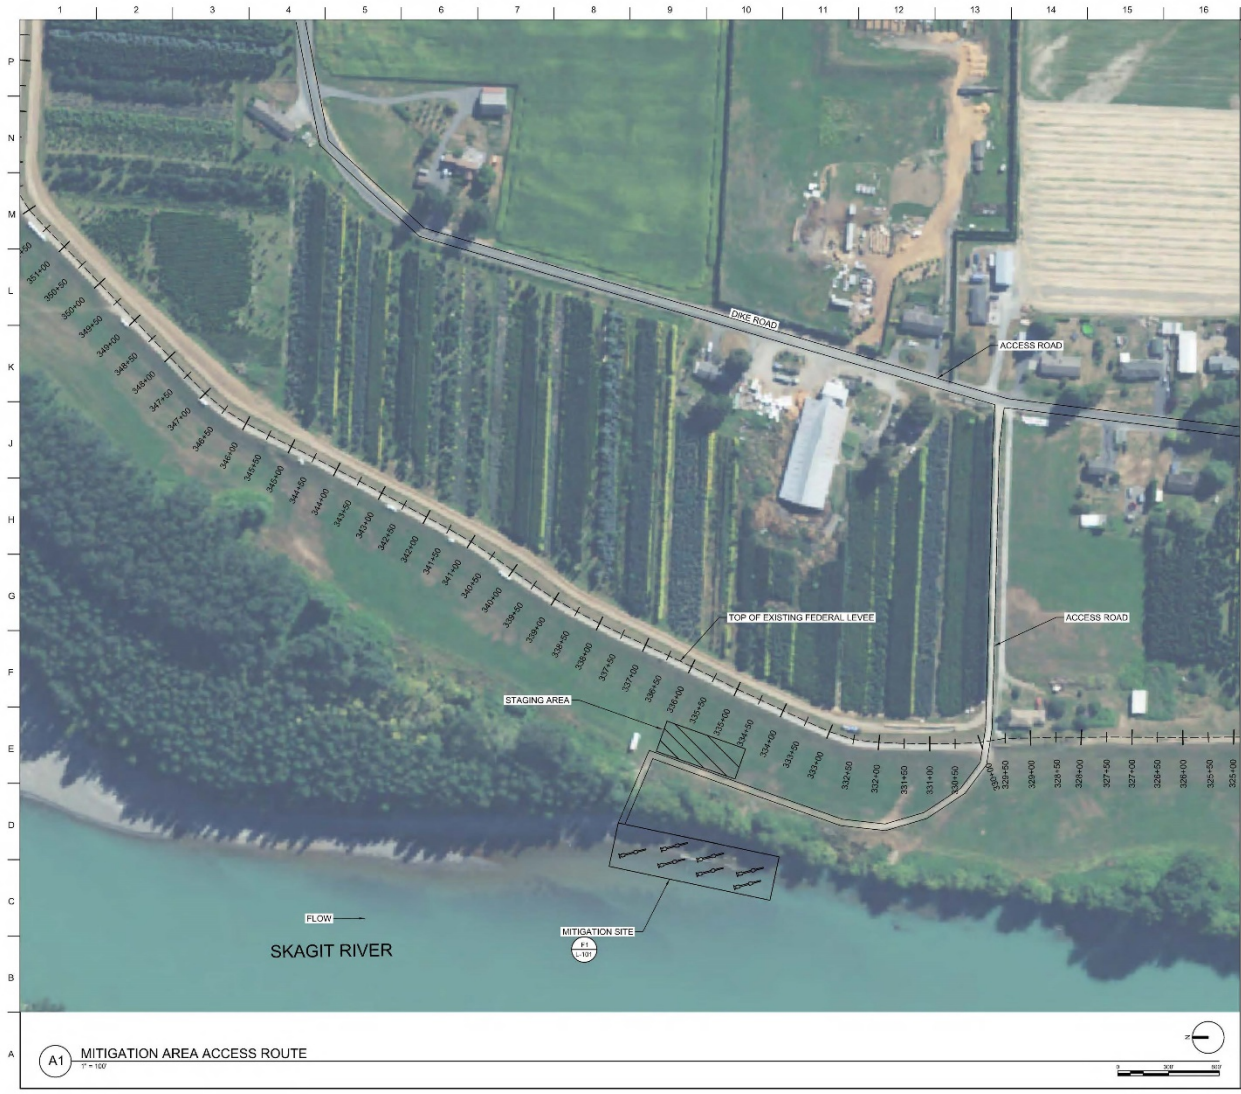
- GENERAL NOTES:**
1. ACCESS SITE FROM DIKE ROAD.
 2. UPON PROJECT COMPLETION, STAGING AREA WILL BE COVERED IN TOPSOIL, IF POSSIBLE, TO MATCH EXISTING CONDITIONS PRIOR TO CONSTRUCTION.
 3. ASSOCIATED LEVEE REPAIR LOCATED AT ST. 438+75 TO 438+25. SEE SHEETS CS-100, CS-101, AND CS-901.

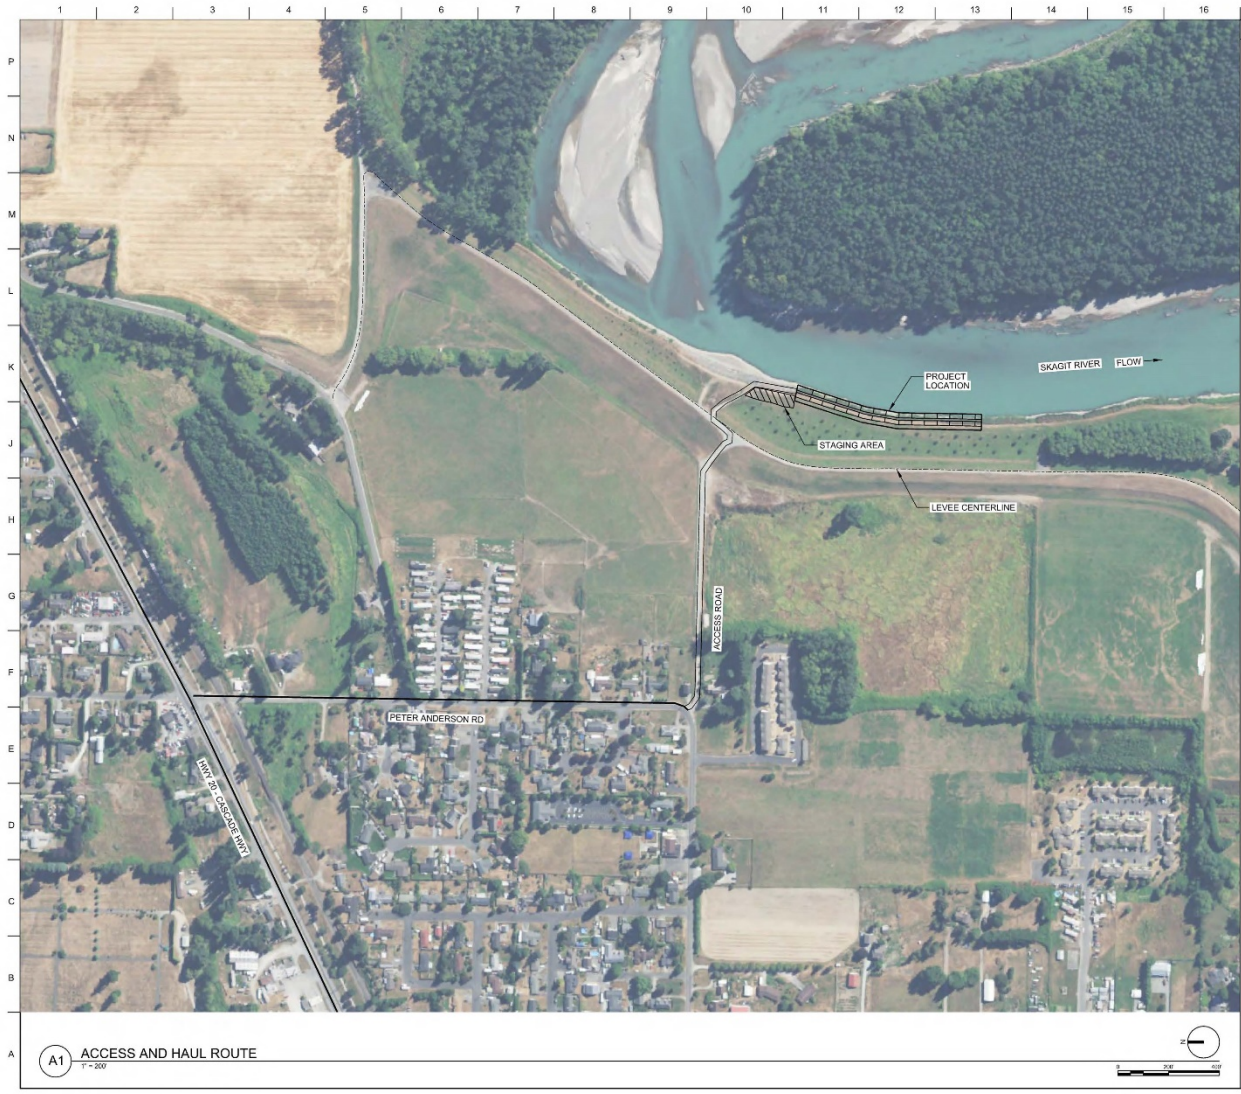
A1 ACCESS AND HAUL ROUTE
1" = 200'

GENERAL NOTES:
 1. PROJECT ACCESS WILL BE FROM HIGHWAY 20 ONTO PETER ANDERSON ROAD.
 2. STAGING AREA WILL BE COVERED IN TOPSOIL, HYDROSEEDING AND MATCH THE EXISTING CONDITIONS PRIOR TO CONSTRUCTION.

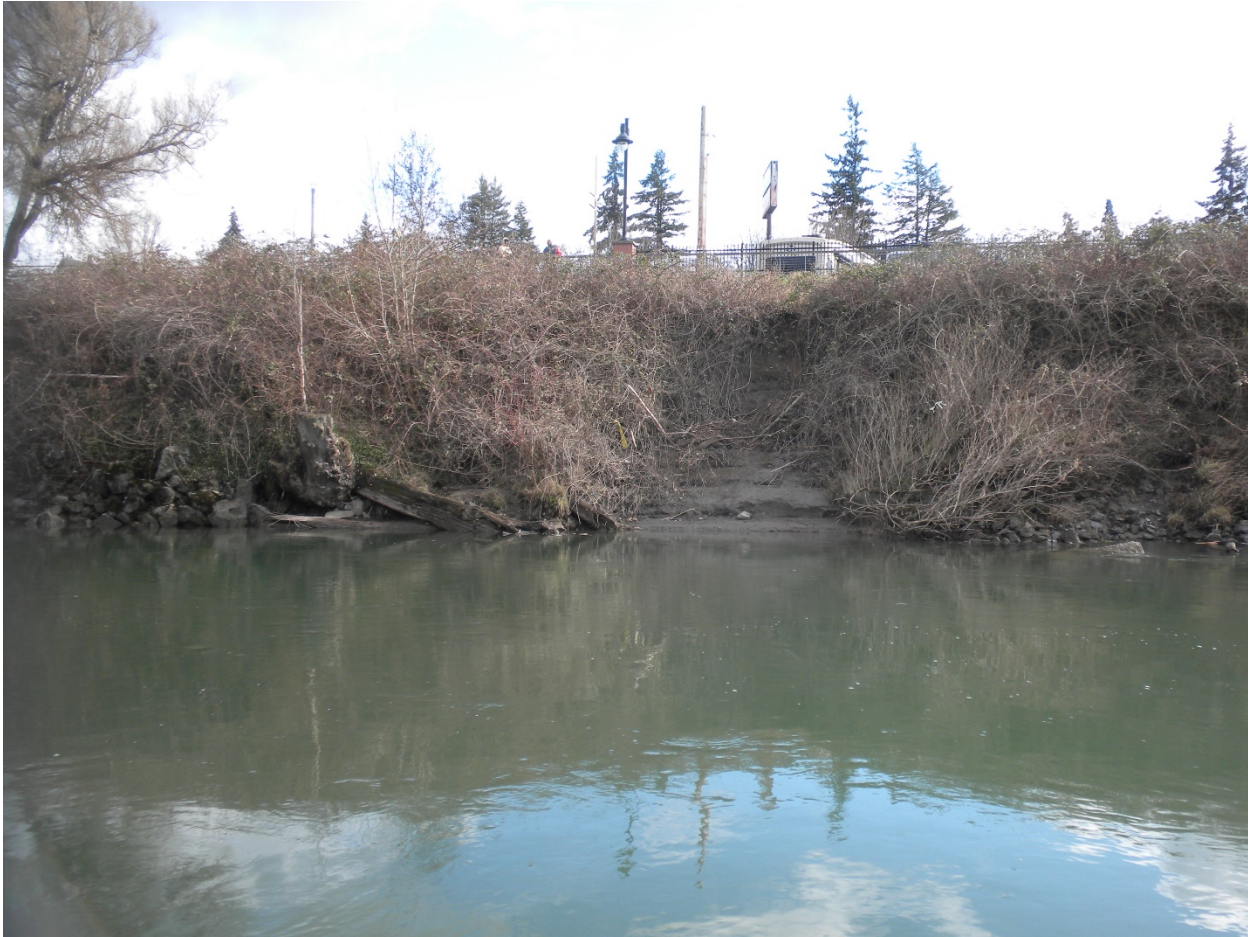
Figure 1. DD 3 repair site showing slope failure.

At DD 3 a slope failure occurred near Station 429+00 along approximately 60 linear feet (LF) of the levee due to a combination of riprap being scoured from the riverward toe and slope failure

due to saturated conditions of the embankment material (Appendix B, Figures 1 and 2). The failure created a near-vertical head scarp roughly 15 feet tall. This failure threatens the sheetpile cutoff and the approximately 3.5-foot tall floodwall constructed along the landward edge of the levee crest. In the damaged condition, the DD 3 levee is providing a 1-year flood (100% ACE) level of protection.

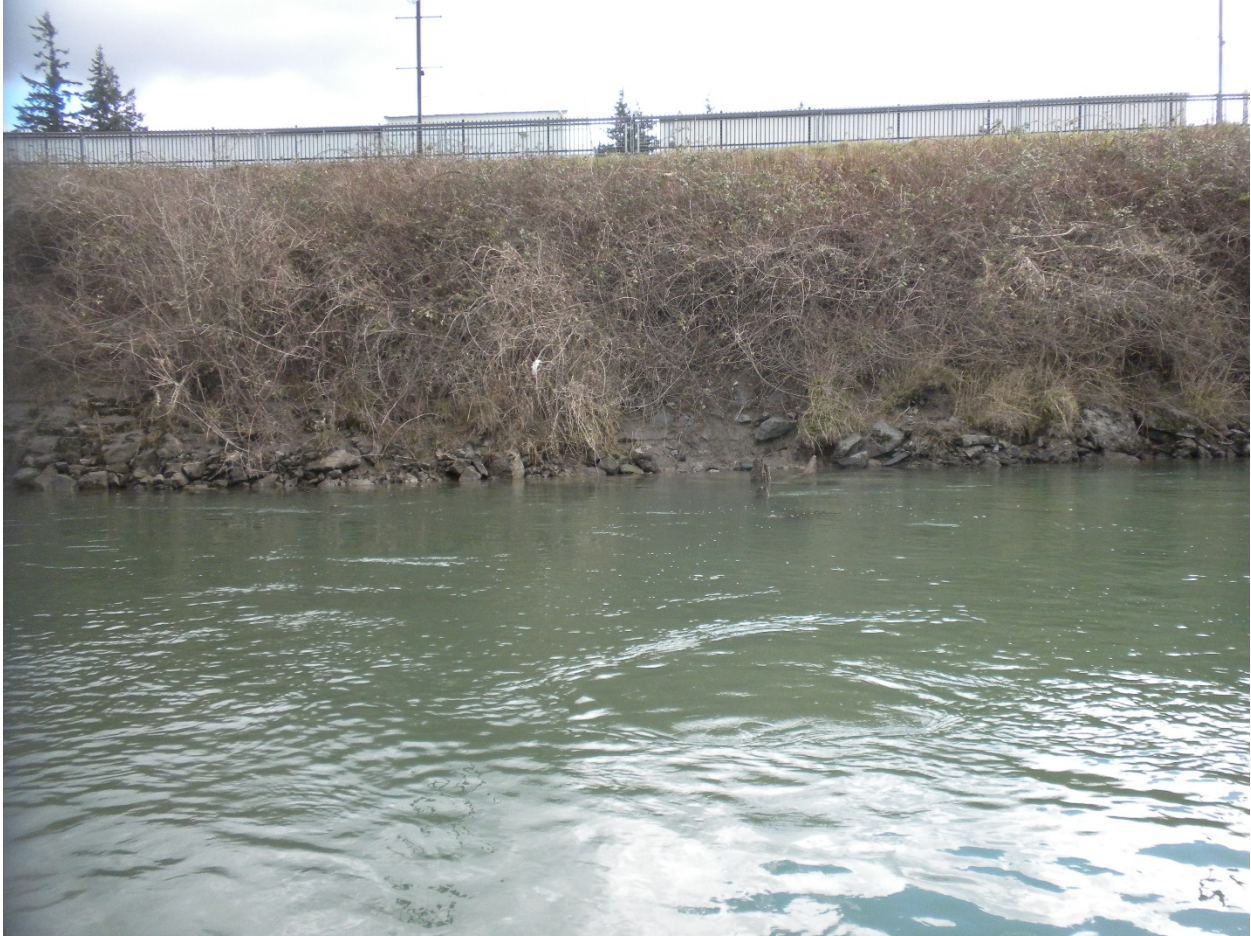
Figure 2. DD 3 damaged segment scour.

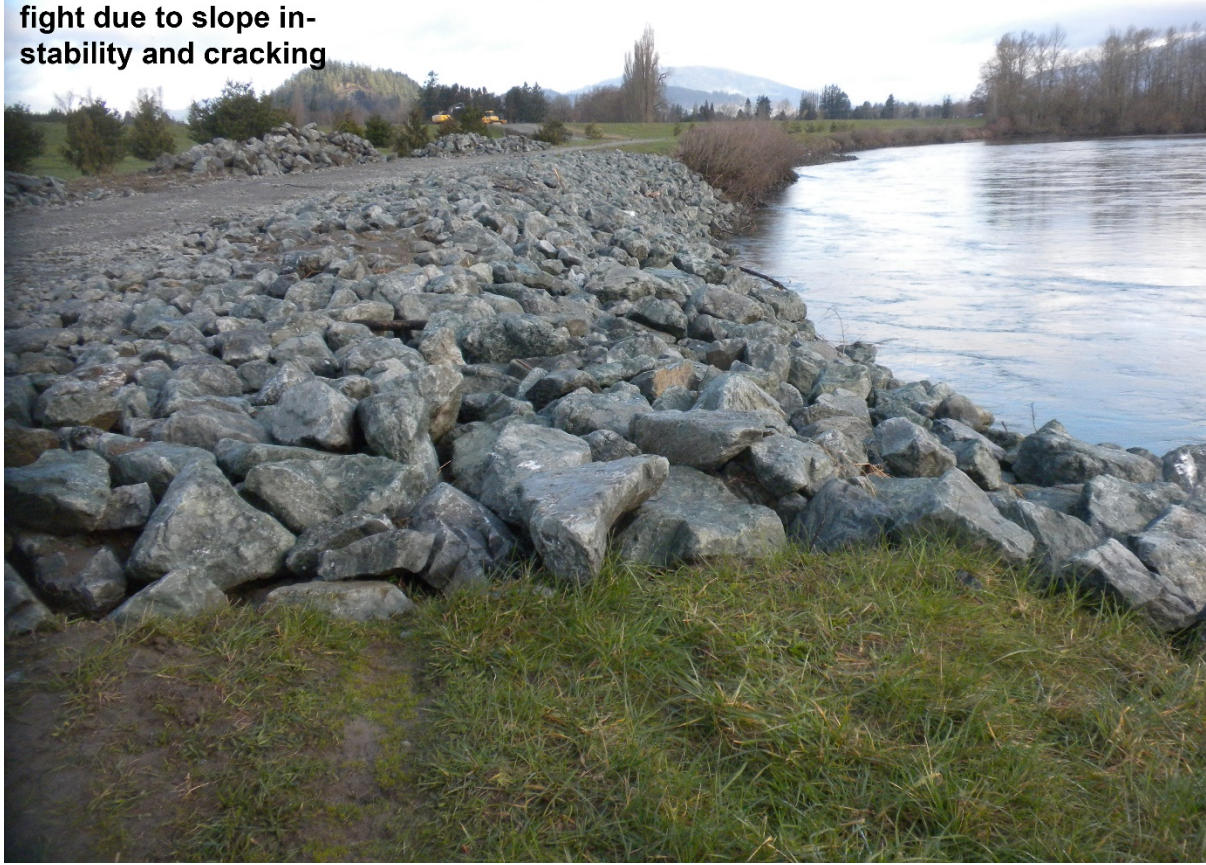
**Skagit DD12 Flood
fight due to slope in-
stability and cracking**

Figure 3. DD 12 300 LF flood fight segment looking upstream.

At DD 12, the Sponsor noted cracking in the bench between the levee and the river during the February flood event (Appendix B, Figures 3 and 4). This bench and the associated riprap armoring is critical to the levee performance and has been evaluated as an appurtenant levee component in previous levee inspections. The purpose of the emergency repair was to temporarily provide supplemental protection to prevent levee failure. During the flood event, the Sponsor began emergency construction of an access road to reach the damaged section, using quarry spalls and geofabric. The Corps took over the flood fight response and constructed emergency bank stabilization over approximately 300 LF of the bench, between roughly Stations 300+00 and 303+00 (Appendix B, Figure 3). After floodwaters receded, the sponsor observed additional cracking in the silt bench extending approximately 200 feet on either side of the repair. This cracking indicated that the riverward slope of the bench is unstable and continues to slide into the river. In all, the damaged area is approximately located between Stations 298+00 and 305+00. In the damaged condition, the DD 12 levee is providing a 1-year flood (100% ACE) level of protection.

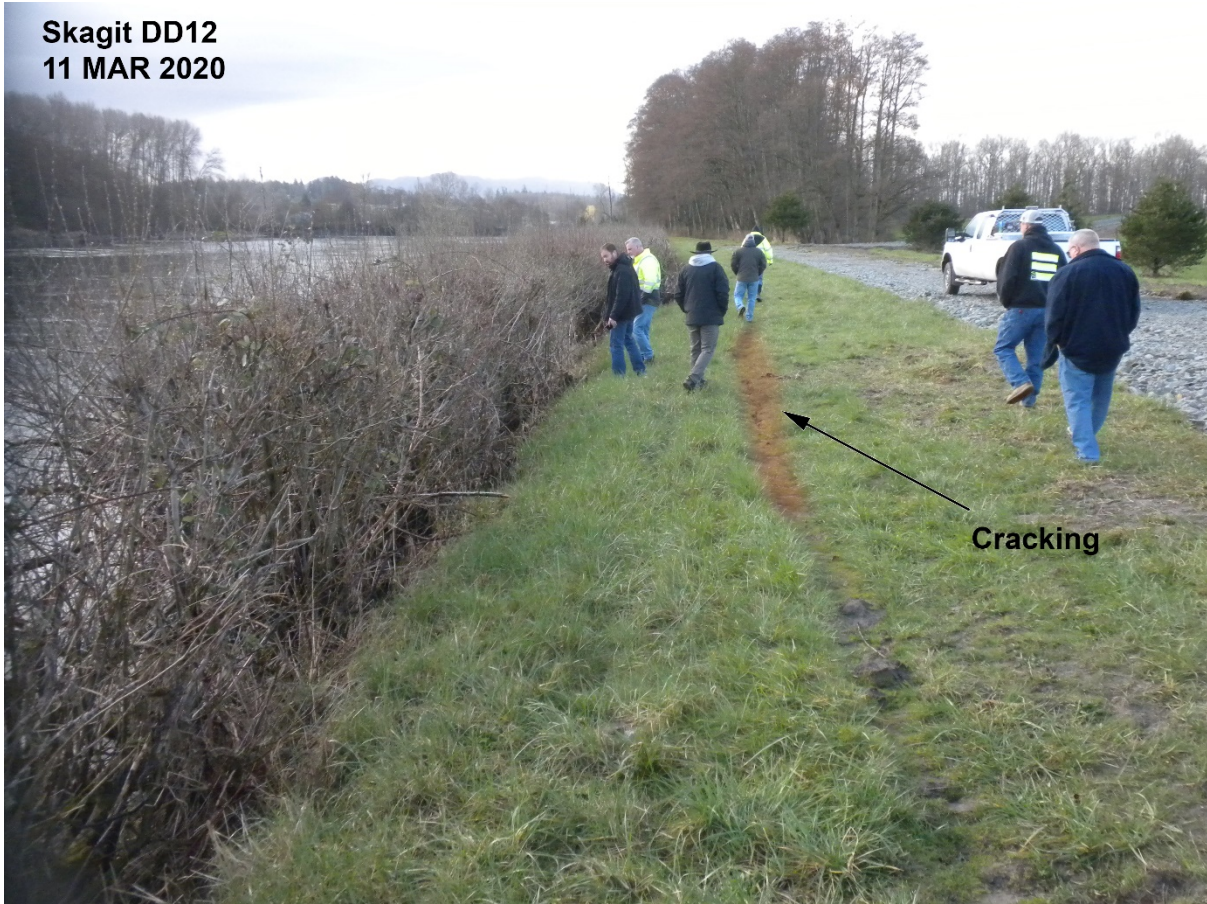
Figure 4. DD 12 cracking along the riverward bench.

Repairing the DD 12 levee in-place is recommended to restore the levee to its pre-damaged level of protection. However, extensive cracking along the riverward bench slope indicates that the toe erosion has destabilized the 2H:1V slope. The damaged slope would be laid back to 3H:1V resulting in both increased stabilization and high-water refuge habitat. Any sloughed material would be removed from the slope and suitable flood fight material would be salvaged for reuse into the final repair. The downstream extent of the repair would incorporate a launchable toe using 4 feet of Class V riprap. The damaged riverward slope would be re-armored with a 4-foot thick blanket of Class V riprap placed over a 12-inch layer of quarry spalls which is an increase in size from the existing Class IV riprap. The upstream and downstream ends would be smoothly transitioned into the existing slopes. All repairs would occur within the pre-damage footprint. Total rehabilitation construction length is 700 LF, which includes any necessary transitions. Topsoil and native hydroseed would be placed in all areas indicated on the plans to restore the project to the existing condition prior to construction.
